AN ORDINANCE      2008 - 01 - 31 - 0085

**APPROVING A MASTER PLAN FOR THE JAPANESE TEA GARDEN IN BRACKENRIDGE PARK DEVELOPED IN COOPERATION WITH THE SAN ANTONIO PARKS FOUNDATION, AND THE FRIENDS OF THE PARKS.**

existing conditions :: limit of work

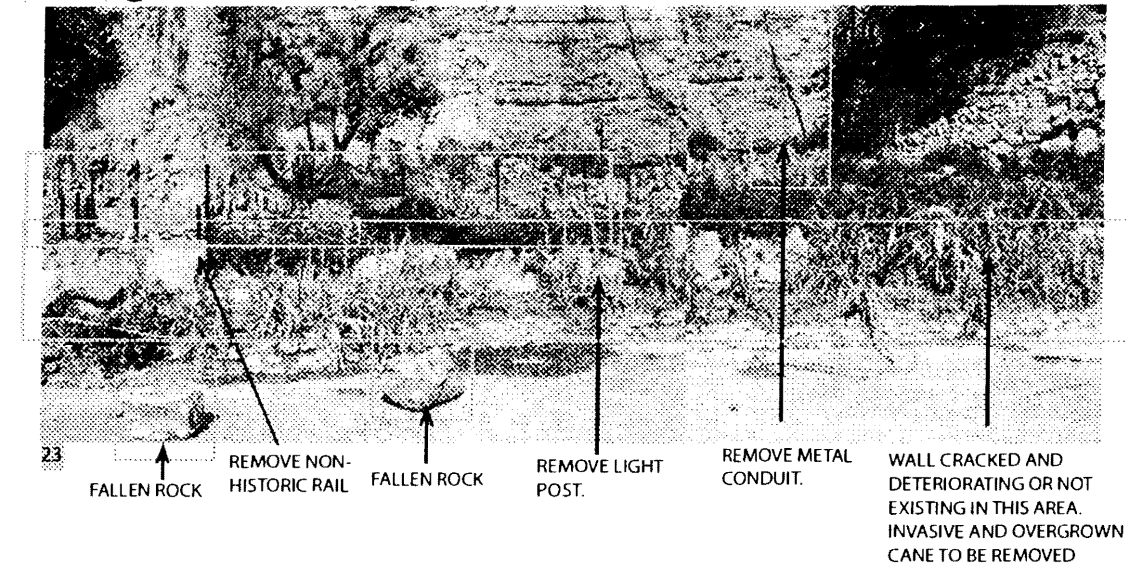
23. The pond wall in this portion has been compromised by overgrown and invasive cane. The cane should be removed. The pond wall is cracked, deteriorating, or even missing in much of this portion. The area is also impacted by rock slides from above. Measures should be taken to prevent future rock slides. Securing Alpine Drive from above will be a great step towards this measure (see safety and security analysis).

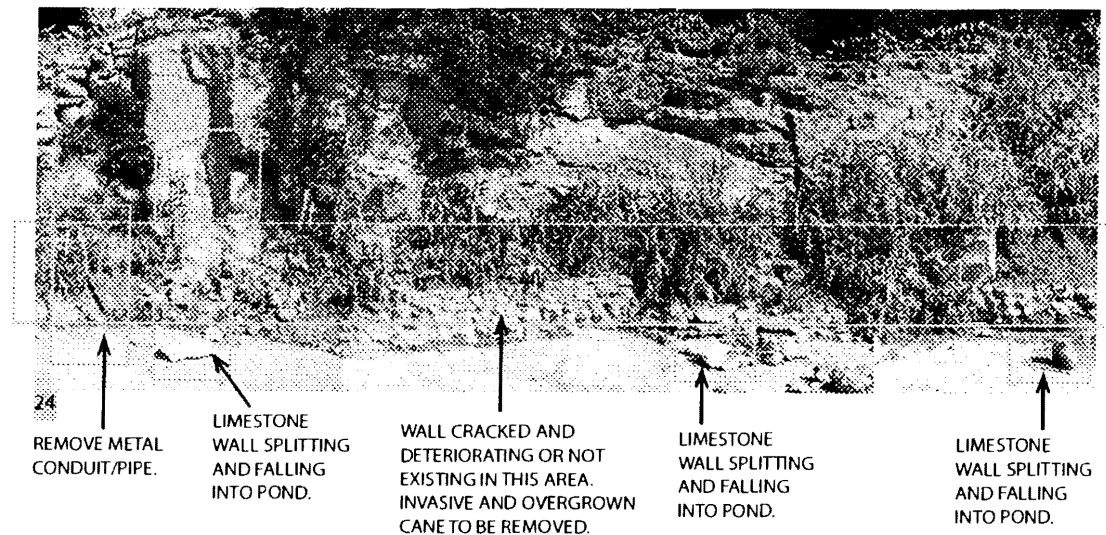
24. The pond wall in this portion has been compromised by overgrown and invasive cane. The pond wall is cracked, deteriorating, or even missing in much of this portion. The area is also impacted by rock slides from above. Measures should be taken to prevent future rock slides. Securing Alpine Drive from above will be a great step towards this measure (see safety and security analysis). The cane should be removed. Repair wall as necessary.

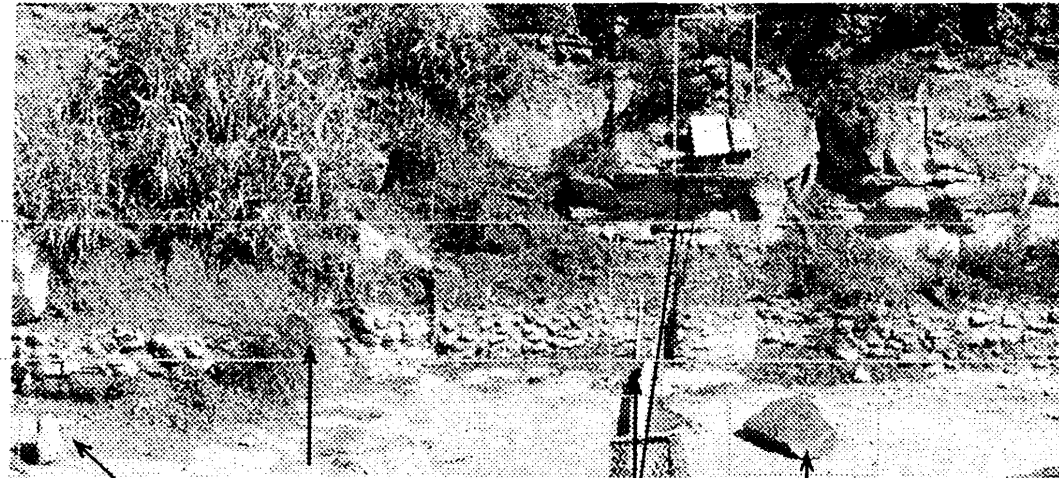
25  
FALLEN ROCK  
WALL CRACKED AND DETERIORATING OR NOT EXISTING IN THIS AREA. INVASIVE AND OVERGROWN CANE TO BE REMOVED.  
REMOVE METAL CONDUIT, PIPE + ELECTRICAL PANEL.  
FALLEN ROCK

25. The pond wall in this portion has been compromised by overgrown and invasive cane. Remove cane. The pond wall is cracked, deteriorating, or even missing in much of this portion. The area is also impacted by rock slides from above. Measures should be taken to prevent future rock slides. Securing Alpine Drive from above will be a great step towards this measure (see safety and security analysis). All exposed piping, conduit and electrical panels should be hidden with either planting or placed in a non-conspicuous location. All unused piping should be removed.

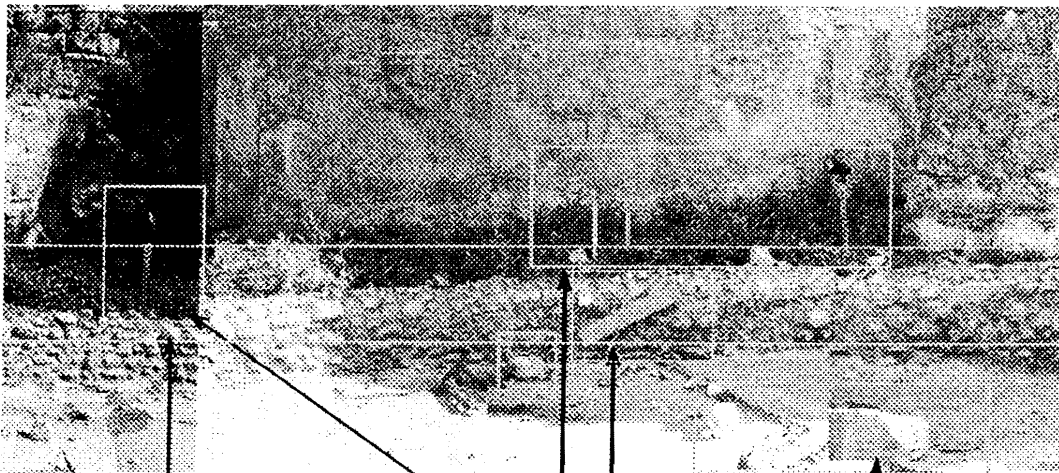
26  
STONE CAP MISSING IN THIS AREA.  
REMOVE METAL POSTS AND LIGHTS. SEE LIGHTING ANALYSIS FOR RECOMMENDATIONS.  
FALLING ROCK.

26. The stone cap is missing in much of this portion. Repair wall as necessary. The area is also impacted by rock slides from above. Securing Alpine Drive from above will be a great step towards this measure (see safety and security analysis). All lights and posts should be removed. See lighting analysis for recommendations. All exposed piping, conduit and electrical panels should be hidden with either planting or placed in a non-conspicuous location. All unused piping should be removed.

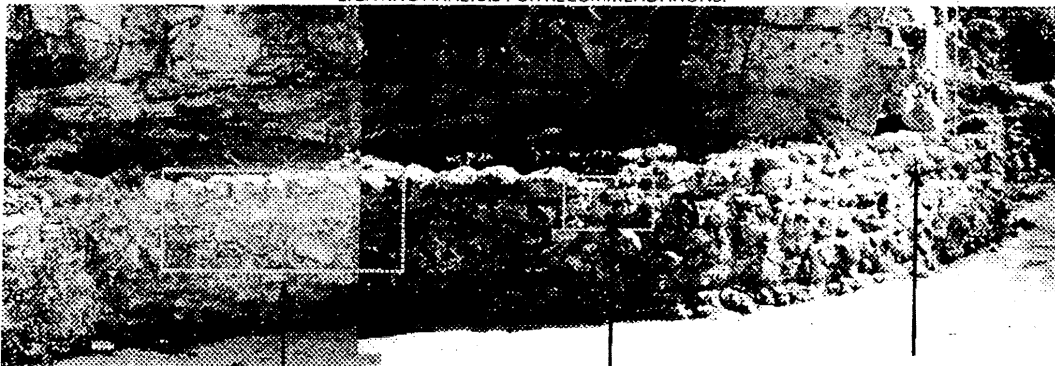
29 WALL CRACKED. STONE CAP MISSING OR DETERIORATING. LIMESTONE WALL DETERIORATING.

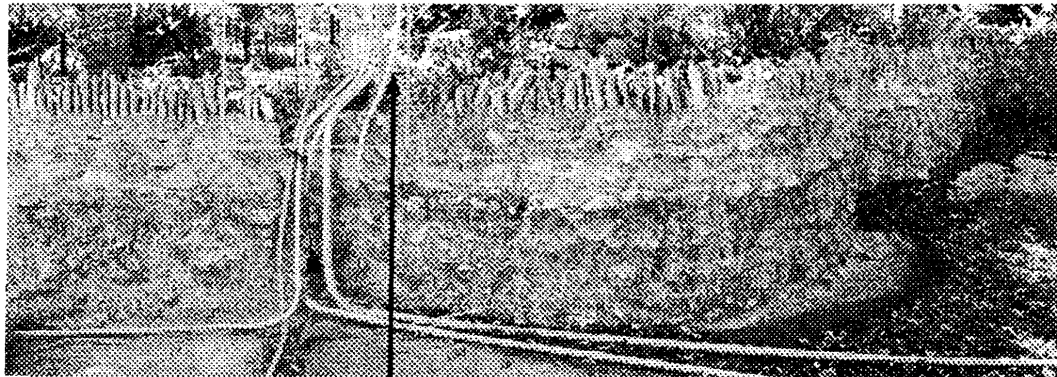
34. A portion of the stone cap is missing because of existing piping and conduit. All piping should be removed or replaced with systems that are inconspicuous and do not take away from the natural setting. Replace stone cap.

CAP MISSING BECAUSE OF EXTENSIVE PIPING IN AREA. REMOVE/PROTECT METAL CONDUIT/PIPE. HIDE WITH PROPOSED PLANTING. PAINT CONDUIT BLACK TO BLEND WITH LINER.

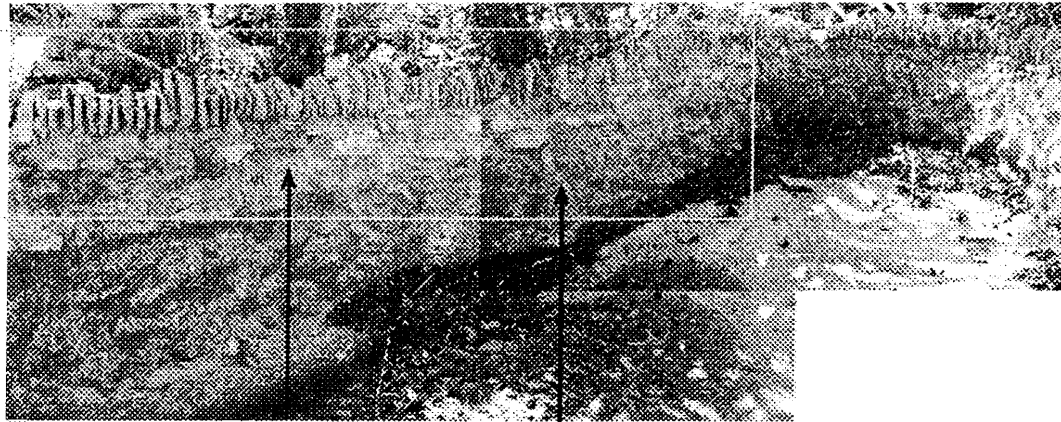
35

TOP TWO FEET OF WALL CRACKING AND DETERIORATING. EVIDENCE OF PREVIOUS REPAIRS.

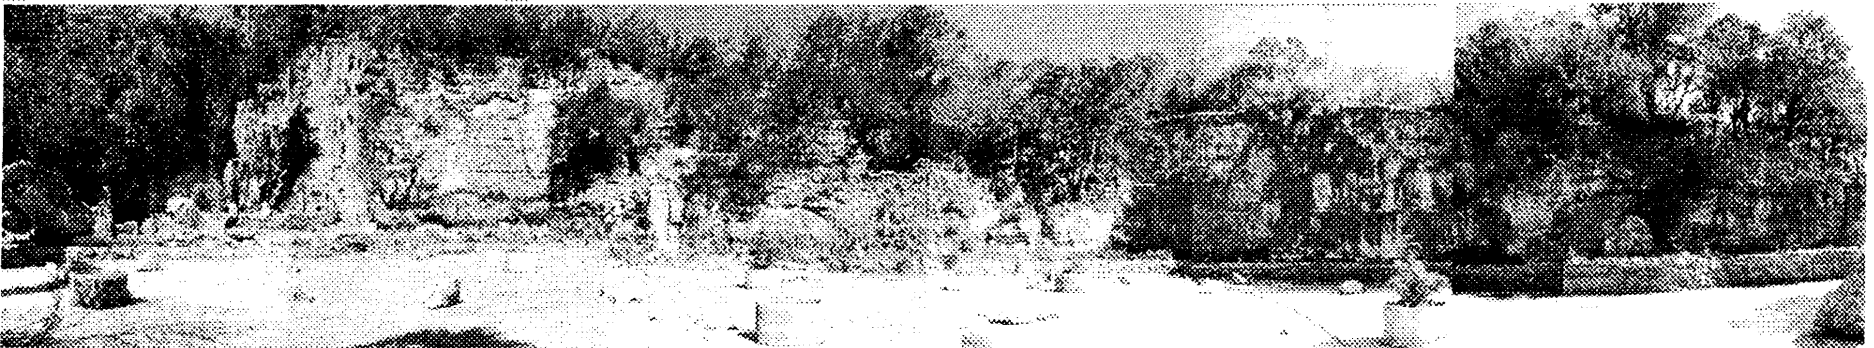
17

- 13. Accessible ramp at Core Garden Island level. The ramp is on top of the historic weir. While the weir is historic, this is the only accessible entry to the island and should be maintained.
- 14. Visitors climbing over Pavilion walls.
- 15. Unsafe drop along Alpine Drive.
- 16. Unsafe drop along Alpine Drive.
- 17. Rock slides from Alpine Drive present a problem to the pathways around the quarry pond.

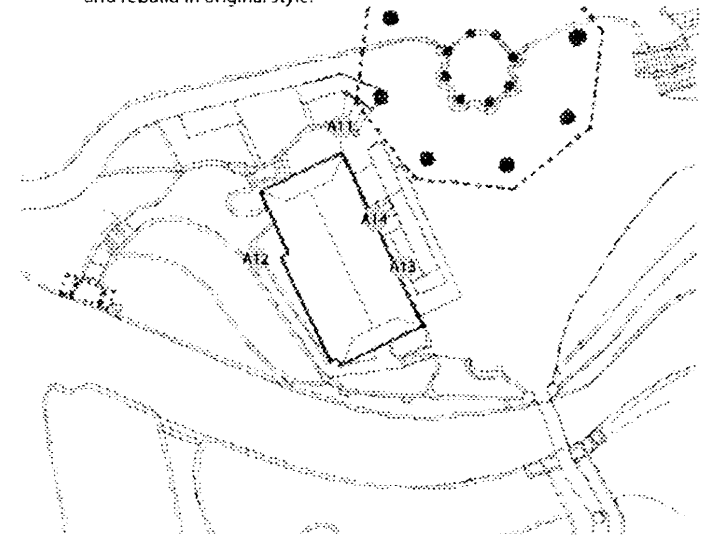
1. Stucco infill at windows; remove and replace with period sensitive window treatment.
2. Stone masonry repair area
3. Continuous vertical crack; repoint mortar as necessary.
4. Continuous horizontal crack at 2nd floor line; 3" gap at steps; assess for structural stability and repair as necessary.
5. CMU infill, typ. Remove and replace with period sensitive window treatment.
6. Security screens at windows, & transoms unsympathetic, typ. Remove and replace with period sensitive window treatment.
7. Doors and screens unsympathetic, typ. Remove and replace.
8. Stone infill does not match style of original masonry. Remove unsympathetic stone and rebuild in original style.
9. Top of stone wall deteriorated along eave line. Remove unsympathetic stone and rebuild in original style.
10. Unsympathetic stone infill below window; Remove unsympathetic stone and rebuild in original style.

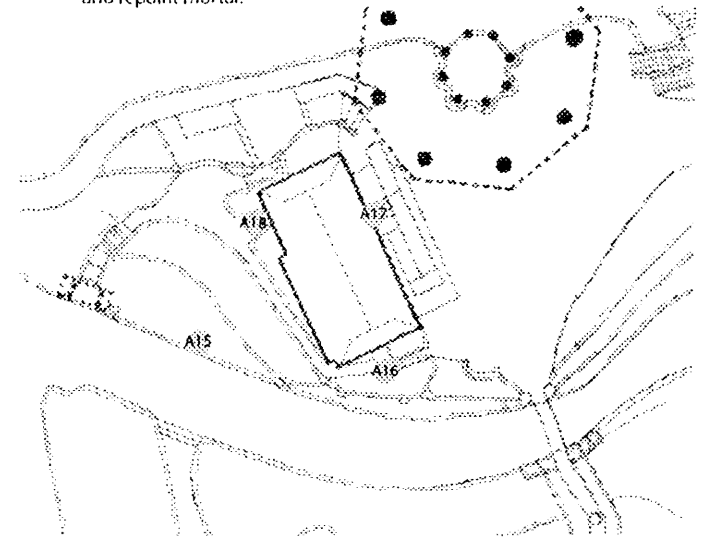
1. Stucco panel infill at screen porch and window locations; remove and replace with period sensitive window treatment.
2. Remove, relocate, or screen exposed HVAC equipment.
3. Relocate overhead telephone lines (to underground.)
4. Stone masonry in disrepair; repair/repoint as necessary, typ. Exposed wood several locations, typ.
5. Wood door deteriorated, screen door missing. Remove and replace with period door.
6. Restroom HVAC equipment; relocate or screen as necessary.
7. Mortar cracked at screen door frames, typ. repoint mortar as necessary for stabilization.
8. Water damage, vertical crack at low stone masonry wall. Clean stone wall and repoint mortar.

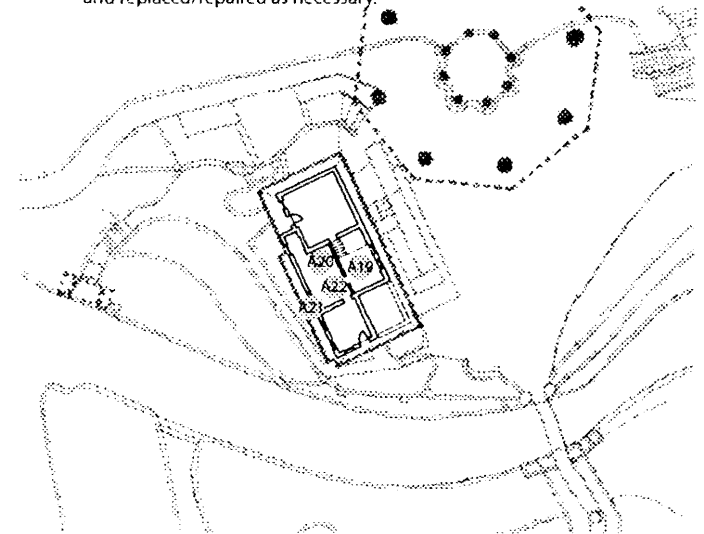
1. High-low ceiling condition at grade transition above (stairs from upper level are visible.)
2. New steel shoring supporting 2nd floor, typ. (Installed during restroom renovation; supported on concrete floor with wood blocking.) Future use to determine more appropriate structural reinforcement
3. Major water damage to 2nd floor structure throughout; remove and replace damaged structure
4. Window infill panels do not appear to be damproofed/waterproofed; remove infill and replace with period sensitive treatment
5. Concrete floor uneven and not level; appears to be infill without water barrier (sweating.) Relevel/rebuild floor as appropriate for future use
6. Exposed piping in poor condition, typ; clearance under pipes less than 7'-0" clear in some areas. Piping needs to be determined for future use and replaced/repared as necessary.

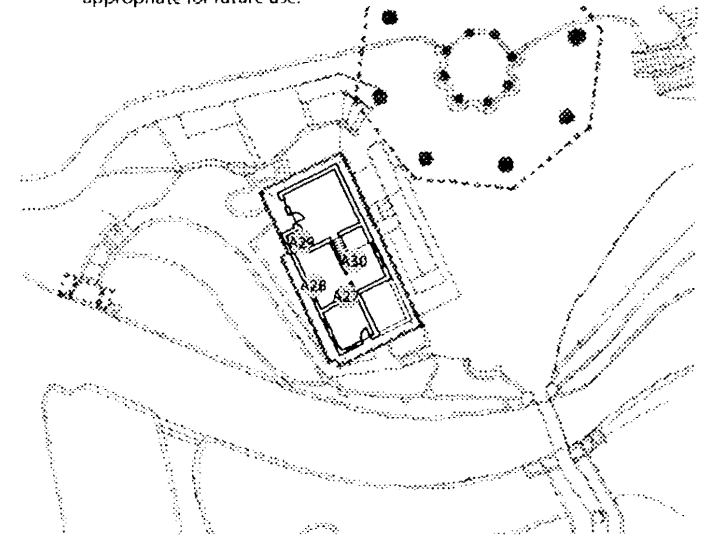
1. Door frames are deteriorated, wood rotted, typ. Remove and replace with period door.
2. Infill at window locations, typ; do not appear to be dampproofed/ waterproofed; remove and replace with period sensitive window treatment.
3. New patch work at West exterior wall; future use to determine level of interior wall restoration necessary.
4. Water damage at floor, typ; floor uneven. Relevel/rebuild floor as appropriate for future use.

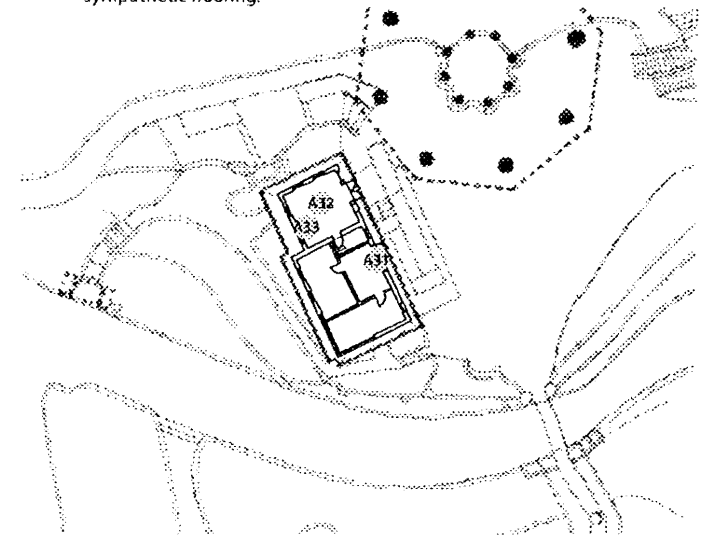
1. Current restroom renovations prohibit preservation of structure to original house plan. Future use will determine needs of this area.
2. Water damage evident at concession stand ceiling, typ. Remove and replace ceiling deck; further damage assesment will be necessary.
3. Light fixtures require bulb guards; electrical work not installed to workman-like standard. Remove and replace with fixtures suited to future use.
4. Vine growth spread to interior, damaging walls. Remove source of vine growth and repair walls as necessary.
5. Plumbing and electrical services exposed; some appear abandoned. Unable to determine if functional; determine future needs and repair or replace as necessary.
6. Water damage at quarry tile floor. Remove and replace with sympathetic flooring.

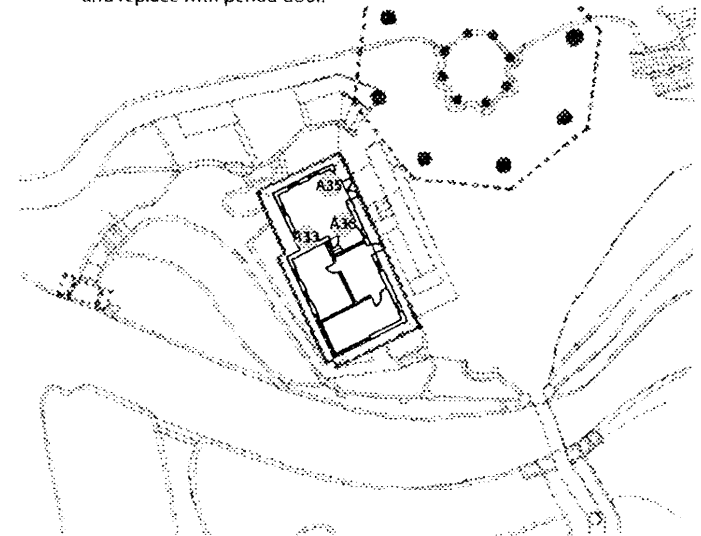
1. Exposed pipe, conduit at interior, typ; insulation in poor or nonexistent condition. Determine needs for future use and repair or replace as necessary.
2. Vine growth on walls; remove source of vine growth and repair walls as necessary.
3. Miscellaneous abandoned kitchen equipment; remove
4. Concession stand in disrepair. Determine needs for future use; remove and discard materials and clean area.
5. Exposed electrical & HVAC lines appear to be disconnected; HVAC condensing unit located on West side of building. Determine needs for future use and remove or replace equipment, conduit, etc.
6. Original walls are in need of repair and restoration.
7. Door does not appear to be original, although location likely is. Remove and replace with period door.

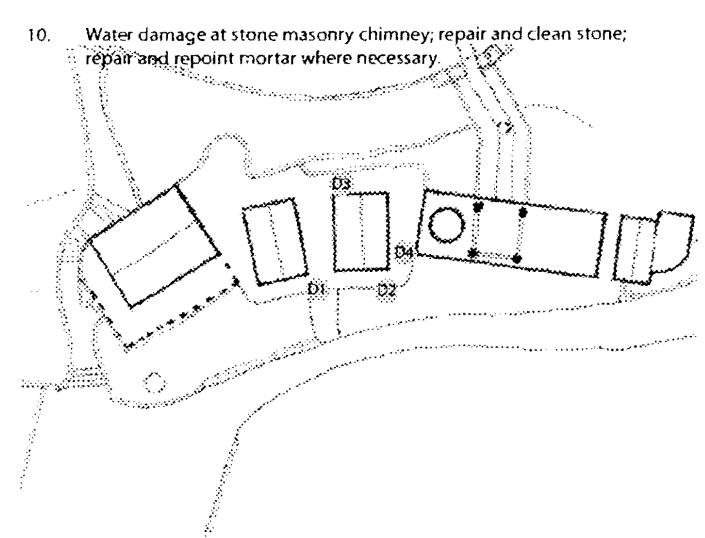
1. Concrete slab cracked/broken, presents unsafe condition; relevel and repair slab for safety and watershed.
2. Plant growth expanding into path; remove source of growth and restore path as needed.
3. Breezeway no longer present; determine feasibility of restoration.
4. Door does not meet ADA clearance requirements
5. Path is inaccessible; incorporate overall accessible path at Historic Mexican Village.
6. Overhead electrical / telephone service; remove all nonfunctional wiring and devices.
7. Area of apparant mortar repair/ patching; remove and replace with period sensitive mortar repair.
8. Grade above building base; regrade for adequate watershed.
9. Exposed wood deteriorated, typ. Determine needs for future use and replace as necessary.
10. Water damage at stone masonry chimney; repair and clean stone; repair and repoint mortar where necessary.

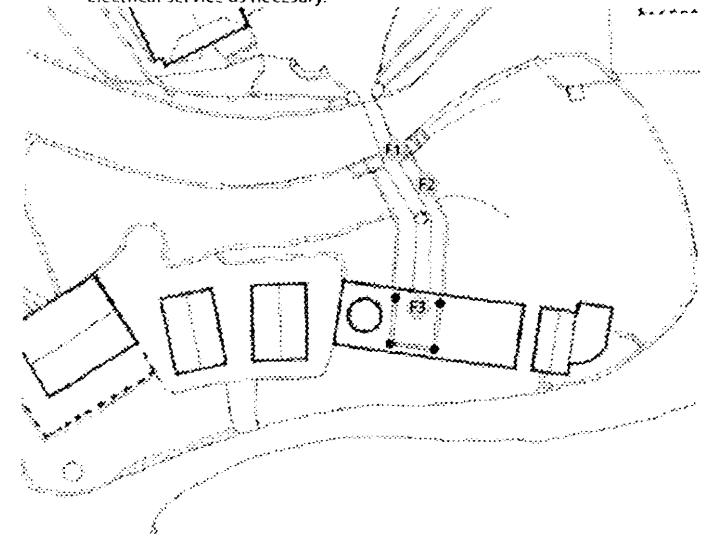
1. Wood bridge decking deteriorated; water damage apparant. Restore and repair as necessary to prevent further deterioration.
2. Hand rail deteriorated, nails exposed, guardrail not code compliant. Remove and install or repair period sensitive railing where needed.
3. Handrail bracing replaced with steel supports; remove and replace with period sensitive cedar post bracing as necessary.
4. Roof at overlook deteriorated, typ. Remove and replace with palapa-style roof.
5. Exposed wiring; remove all nonfunctional wiring and devices.
6. Unable to determine functionality of lighting; restore fixture and install electrical service as necessary.

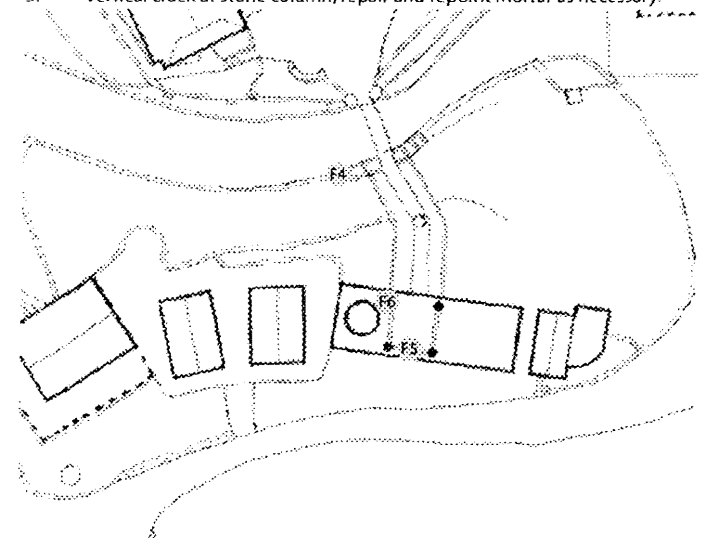
1. Thatched Palapa roof from pavillion no longer present
2. Insufficient guardrail at overlook, presents unsafe condition; determine need and install period sensitive railing where necessary.
3. Roof and structure deteriorated; remove and restore
4. Overgrowth of plants damaging stone masonry; remove source of growth and restore masonry where necessary.
5. Vertical crack at stone column; repair and repoint mortar as necessary.

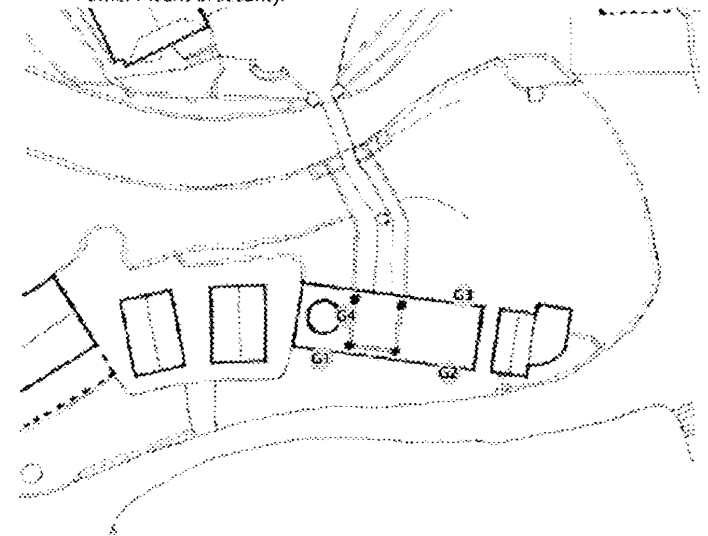
1. Kiln openings require cleaning, restoration
2. Plaque missing/removed from wall; stone masonry damaged; clean and restore.
3. Undefined landscape/ boundary at base. Determine needs for accessible path and delineate if needed.
4. Plant growth damaging historic features; remove source of growth or prohibit future growth and restore masonry where needed.
5. Existing electrical service; recommend removing or relocating
6. Smokestack vandalized near overlook; install preventative guardrail or other means of security.
