AN ORDINANCE      2008 - 01 - 31 - 0085

**APPROVING A MASTER PLAN FOR THE JAPANESE TEA GARDEN IN BRACKENRIDGE PARK DEVELOPED IN COOPERATION WITH THE SAN ANTONIO PARKS FOUNDATION, AND THE FRIENDS OF THE PARKS.**

existing conditions :: limit of work

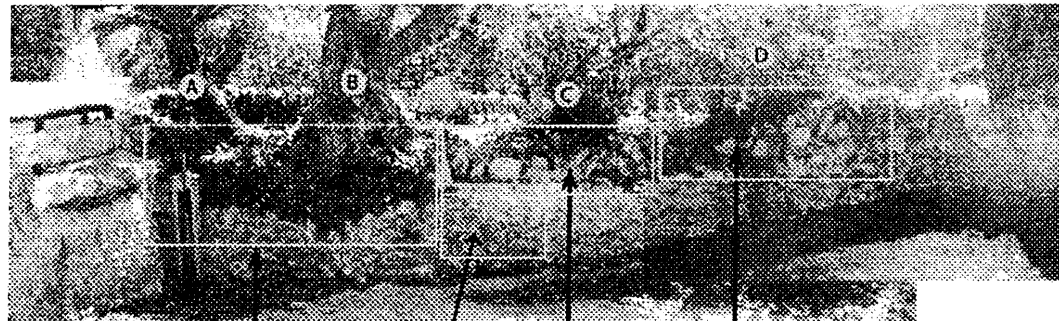
- 1
- TREE ENCROACHING ON WALL. CAP MISSING ENTIRELY.
  - WALL CRACKED
  - TREE ENCROACHING ON WALL AND CAP.
  - TREE ENCROACHING ON WALL AND CAP.

1. Trees have damaged the wall between the pedestrian bridge and arched bridge. The cap is disintegrating or missing in much of this portion. The pressure from the surrounding vegetation has also caused the wall to crack below the stone cap in portions. The City of San Antonio does not generally support the removal of trees on the property. Trees A, B, C and D. should be evaluated for aesthetics, safety, health, etc. by various City staff, the consultants, and contractors involved in Master Plan implementation to determine the best for the facility. Replace wall as necessary.

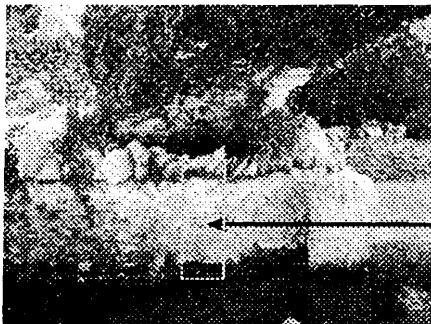
- 2
- WALL CRACKED

2. The wall below the dragon bridge closest to the pavilion is in good condition. There is a crack in one area. The bridge is covered in ivy, which needs to be removed. All roots should be removed from the rock face. Repair wall as necessary.

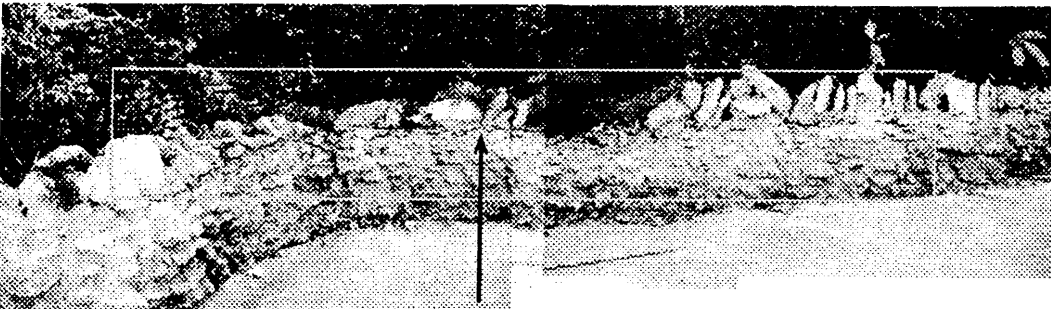
- 3
- CAP CRACKED, DETERIORATING OR MISSING.

3. There are a couple areas where the wall cap is cracked, deteriorating or missing. When replacing the stone cap, the size of the rock used should be similar to the historic wall cap. Larger rock has been used in some areas where the stone cap has been replaced and does not match the predominate vertical arrangement. Stone cap should be replaced with historic vertical stone cap treatment.

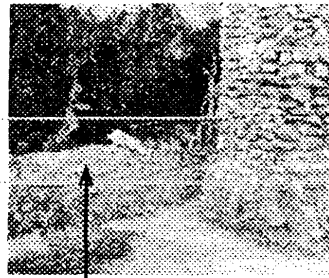
4 CAP MISSING.

4. The cap is missing entirely in this section. Replace stone cap.
5. Wall and cap in good condition beginning behind Pavilion column.
6. Wall and cap in good condition beginning behind Pavilion column. Cap appears to have been fixed recently. Stones in the cap appear larger than some of the more historic caps. Replace large stones with historic vertical stone cap treatment.

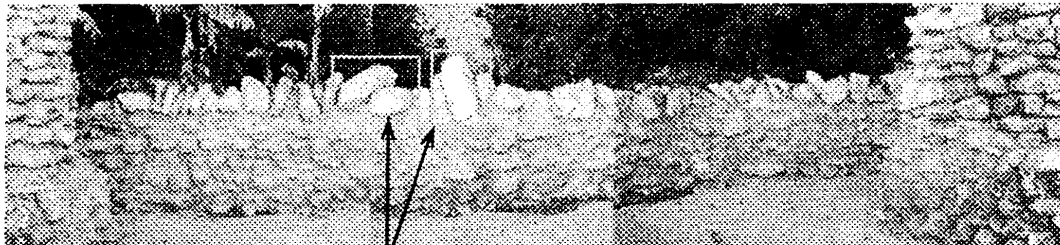
6 STONE OUT OF CHARACTER FROM HISTORIC STONE CAP STONE SIZE.

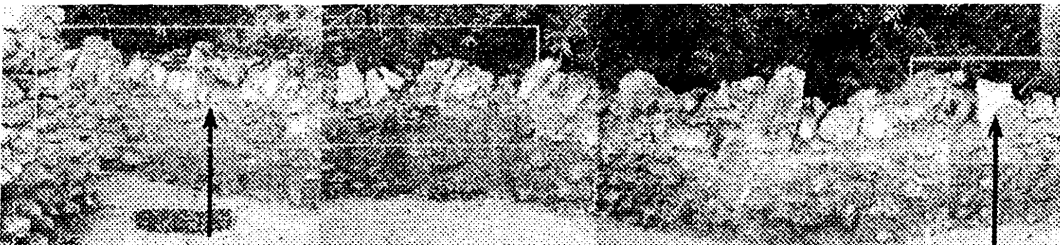
7 CAP CRACKED AND DETERIORATING OR MISSING.

CAP CRACKED AND DETERIORATING.

7. The wall is in good condition in this area. There are a couple areas where the stone cap is missing or deteriorating. Replace stone cap.
8. There are a couple areas where the cap is cracked or deteriorating. The wall is cracked in one area, close to a tree. There is also a rock that has fallen from above. Replace stone cap. Remove fallen rocks and use for restoration projects. Trees were not historically planted in the pond beds, except for banana trees. Consider removing trees A and B. The City of San Antonio, however, does not generally support the removal of trees on the property. Trees A and B should be evaluated for aesthetics, safety, health, etc. by various City staff, the consultants, and contractors involved in Master Plan implementation to determine the best for the facility.

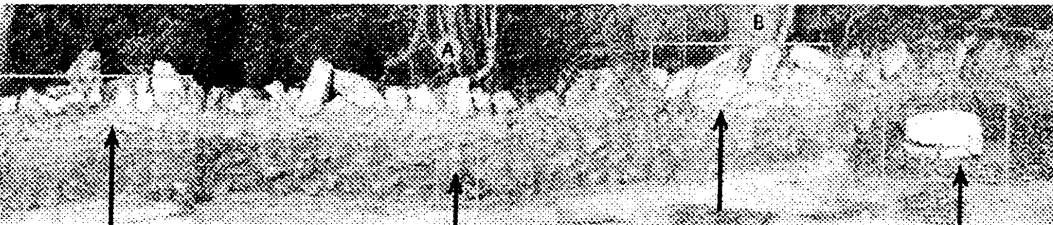
8 CAP CRACKED AND DETERIORATING OR MISSING.

WALL CRACKED

CAP CRACKED AND DETERIORATING.

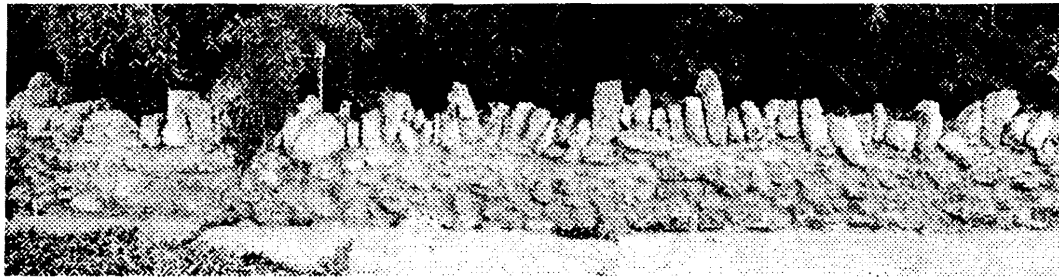
9

9. Wall in good condition

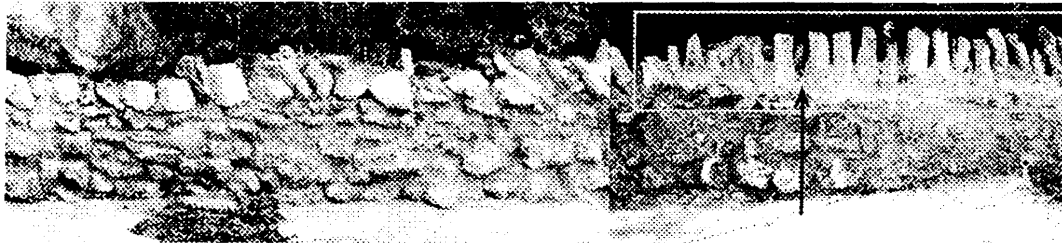
10

CAP RECENTLY REPLACED. CAP STONES LARGER  
THAN MORE HISTORIC CAP.

10. Generally, the wall is in good condition. In one portion, it appears the stone cap has been recently replaced. The cap stones used appear larger than some of the more historic caps.

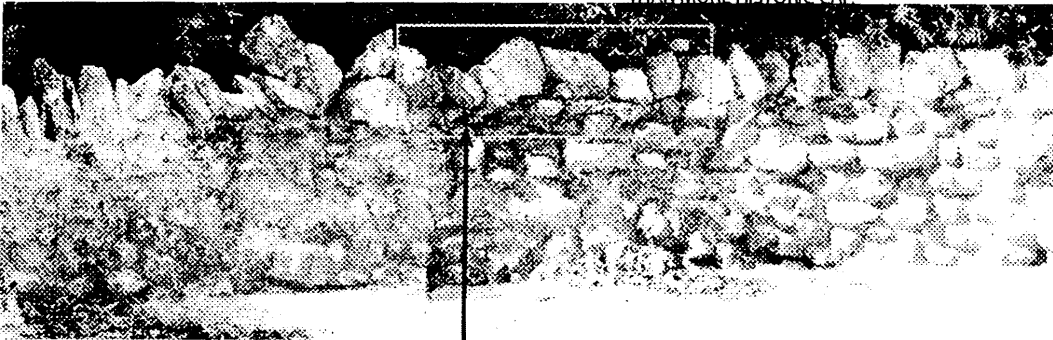
11

CAP CRACKED AND DETERIORATING OR MISSING.

11. Generally, the wall is in good condition. There is one portion where the stone cap is cracked and deteriorating. Replace stone cap.

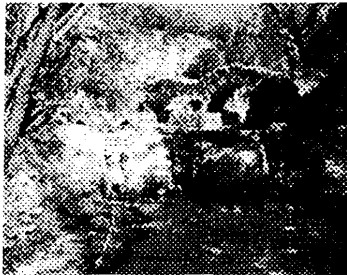
15

15. This portion of the wall is part of the weir. It is not as decorative as other portions of the stone walls. There are no noticeable problems.
16. This portion of the wall is part of the weir. It is not as decorative as other portions of the stone walls. There are no noticeable problems.
17. One of the larger trees is pushing out the wall at the beginning of the weir. The wall is compromised. There is also a portion of the weir where the stone cap is missing.

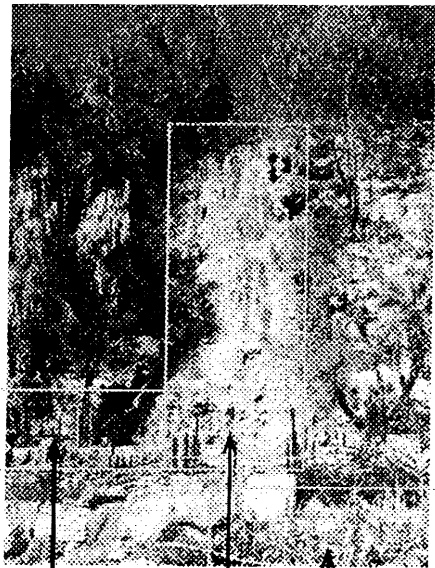
NON-HISTORIC  
SAFETY RAIL

HISTORIC WATER  
FALL WITH DRIED  
MOSS.

Currently, the wall is covered with dried moss and lichen. However, it is believed that once the water is restored to the park, the wall will come to life with lush, moisture loving lichens and moss. There is an overlook in front of the waterfall, which is a great picture spot. It also allows visitors to get closer to the ponds and therefore should be maintained. The black non-historic railing is not necessary if the ponds are re-graded so the railing is not a required safety measure.

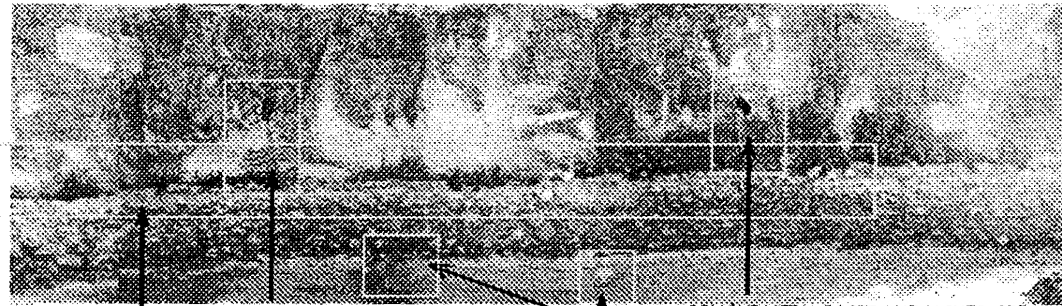
27 STONE CAP MISSING REMOVE METAL POSTS + LIGHTS. OR DETERIORATING. SEE LIGHTING ANALYSIS FOR REC. FALLEN ROCK REMOVE METAL POSTS AND LIGHTS. SEE LIGHTING ANALYSIS FOR RECOMMENDATIONS.

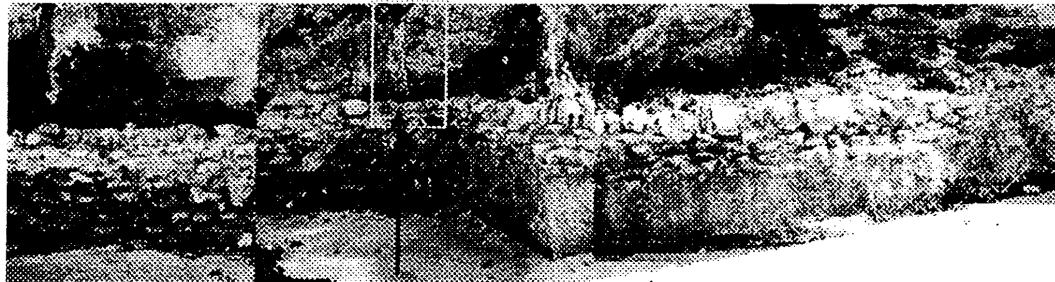
28 REMOVE METAL POSTS AND LIGHTS. SEE LIGHTING ANALYSIS FOR RECOMMENDATIONS.

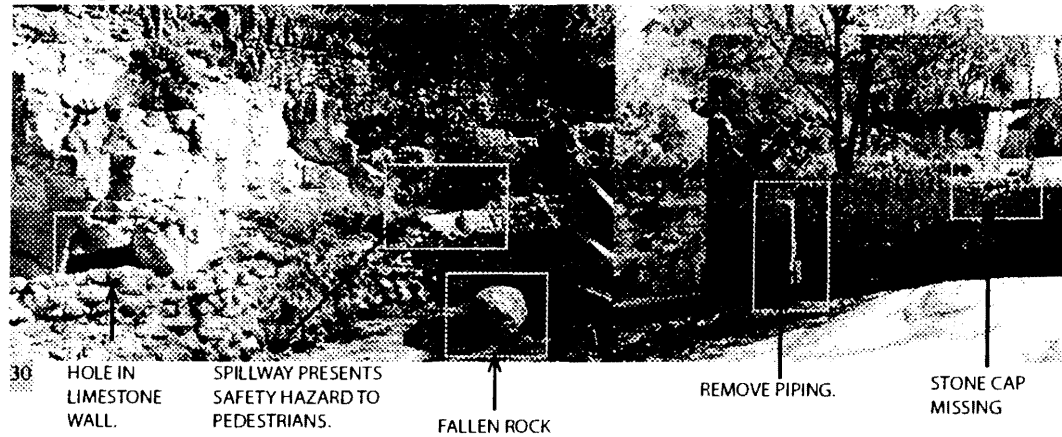
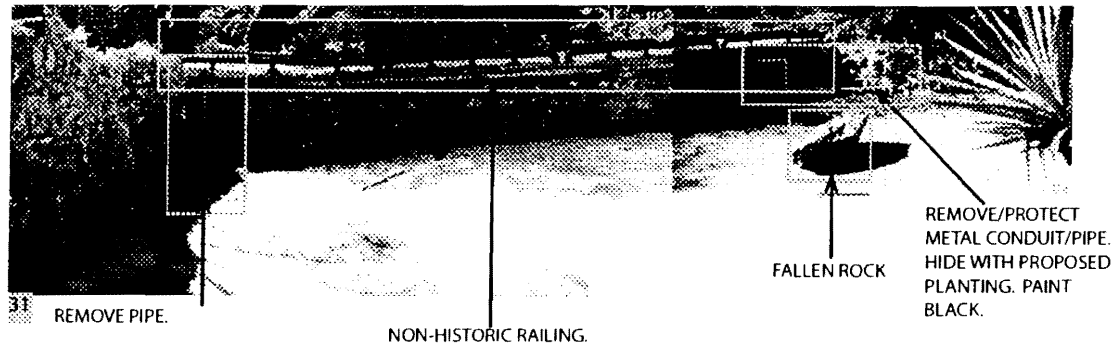
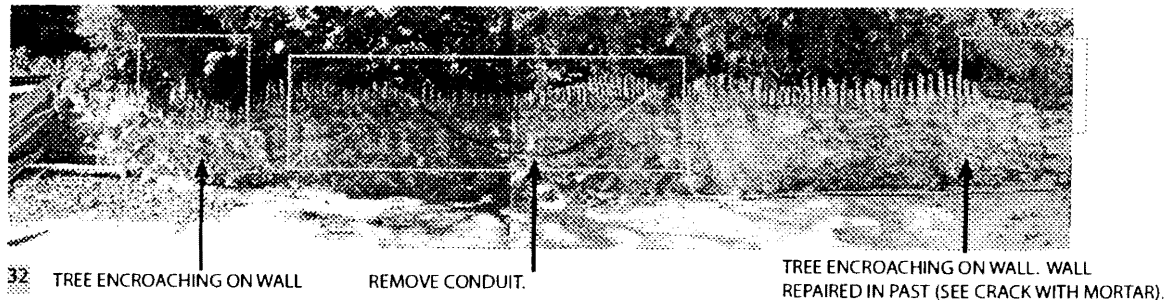
30. Generally, this portion of the wall is in good condition. There is one small section where the stone cap is missing and should be replaced. Fallen rock is coming from the pathways above. All rock should be secured. Also, the addition of perimeter security fencing will prevent trespassers from pushing rock down to the lower portions of the core garden (see safety and security analysis).

Also, all piping should be removed if not in use. Future piping should blend in with the pond liner and be inconspicuous.

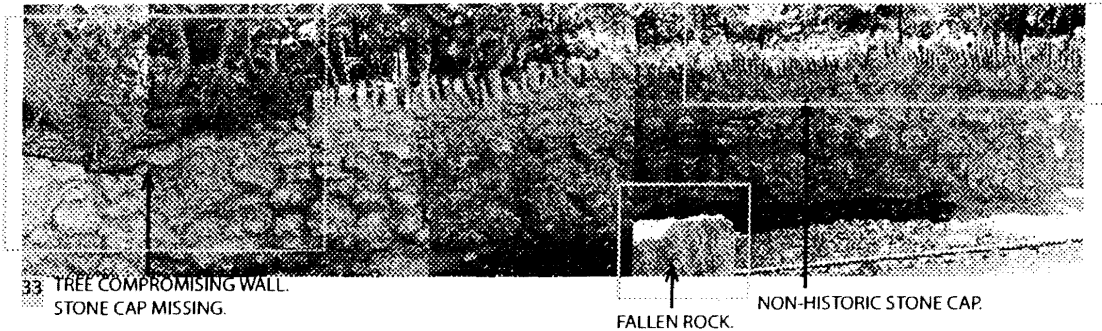
33. A portion of this wall is compromised by an overgrown tree. The tree should be removed. The City of San Antonio does not generally support the removal of trees on the property. All trees to be removed should be evaluated for aesthetics, safety, health, etc. by various City staff, the consultants, and contractors involved in Master Plan implementation to determine the best for the facility.

The wall is cracked and deteriorating. The fallen rock is likely from the other side of the pond, as there are no pathways or walls directly above the enter island. A portion of the stone cap looks like it as been replaced. Smaller stone was used and was placed in a very upright position. All future stone cap restoration should try to match the historic cap as much as possible.

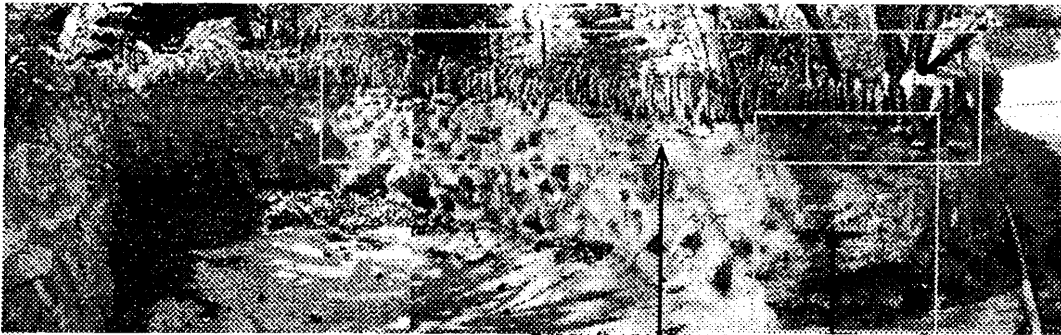
36

EVIDENCE OF PREVIOUS STONE CAP REPAIR.

WALL CRACKED AND DETERIORATING.

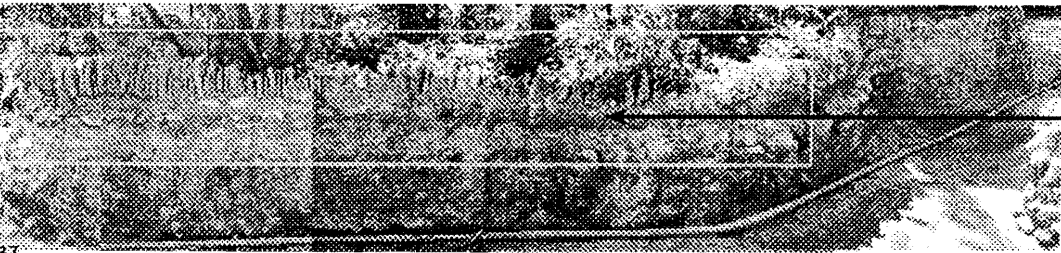
37

EVIDENCE OF PREVIOUS STONE CAP REPAIR.

37. There have been repairs to the cap, but it looks to be in good condition. All piping should be removed or replaced with systems that are inconspicuous, preferably placed underground or are completely hidden.

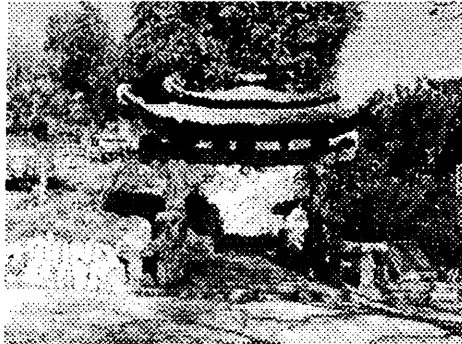
1 & 2. Torii gate by D. Rodriguez. Chinese Tea Garden. The faux bois gate was constructed of concrete, but resembles wood. The gate was constructed in 1942. The gate was constructed after the period of significance, but provides an important opportunity to explain the cultural history of the gardens, the Jingu family and Japanese-American experiences during WWII.

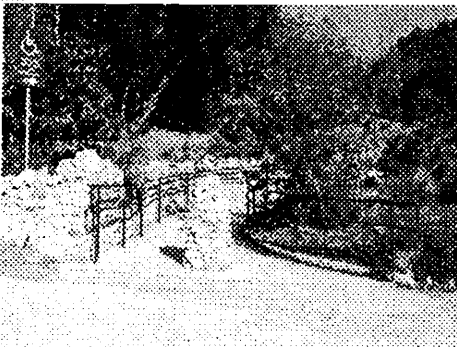
3

3. Accessible ramp entry located to the northwest of the torii gate completed in 1998. The ramp was approved by the Historic and Design Review Commission and the State of Texas Department of Licensing and Regulation. The slope of the ramp is ?? The handrails were a requirement of the State, most likely because of a slope above 5%.
4. Railing and curb along northern edge of the ramp. The curb and rail take away from the entry and are not necessary if the slope is less than 5%.
5. Railing on south side of accessible ramp. Again, this railing takes away from the impact of the entry and is not necessary on the wall side.
6. Accessible ramp at main entry.

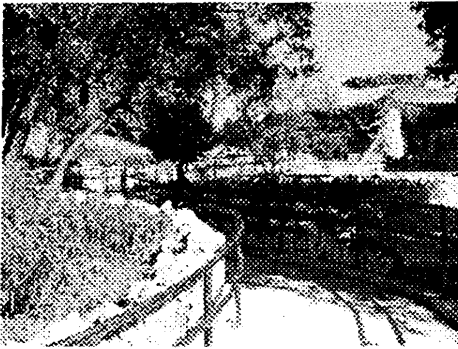
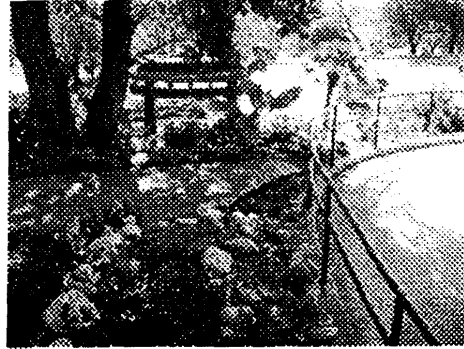
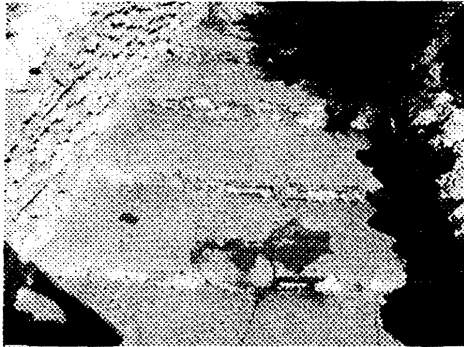
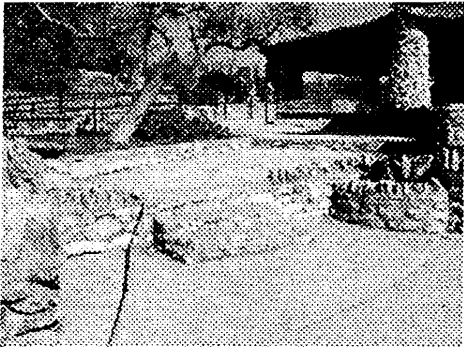
7. Accessible ramp.
8. Part of the existing and historical path system was interrupted to accommodate the accessible ramp. If the ramp is to remain, this remnant path should be removed.
9. Entry steps at Torii gate. The steps are not direct and help to pull visitors up and into the park.
10. Concrete at entry steps cracking and deteriorating. These steps should be fixed, but resemble historic steps throughout the Pavilion area.
11. Main entry steps to Pavilion.
12. Landing off Main Entry stair asphalt should be removed. Stairs might not be historic.

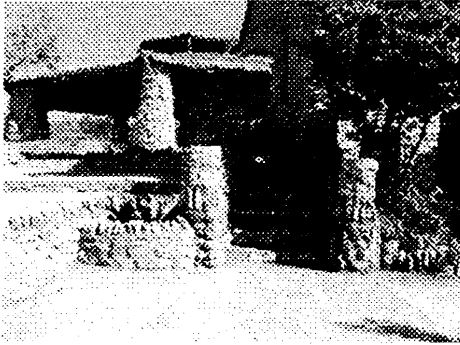
13

13. Landing before Pavilion level.

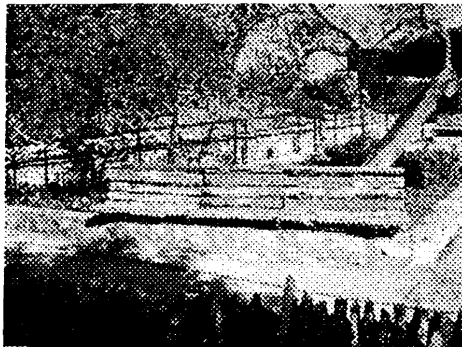
16

16. Planter wall with wooden bench. Benches need to be replaced.

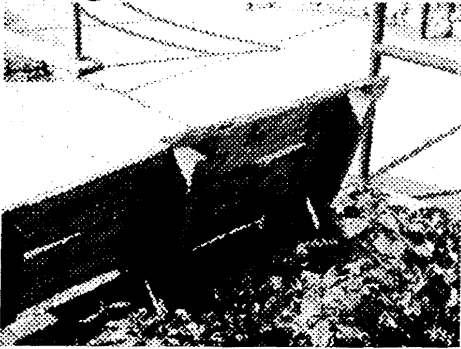
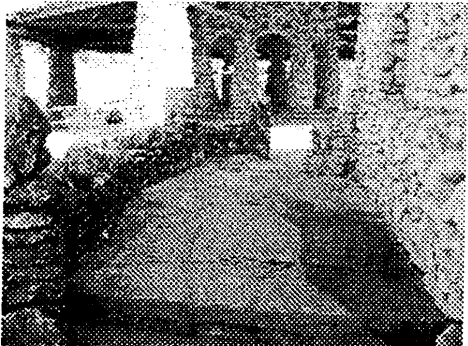
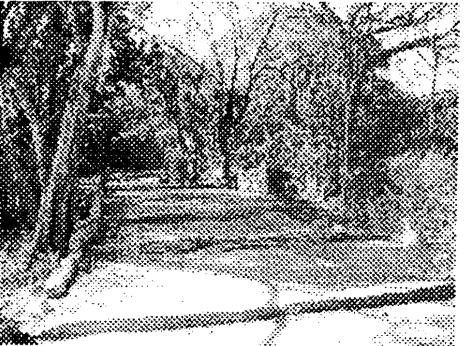
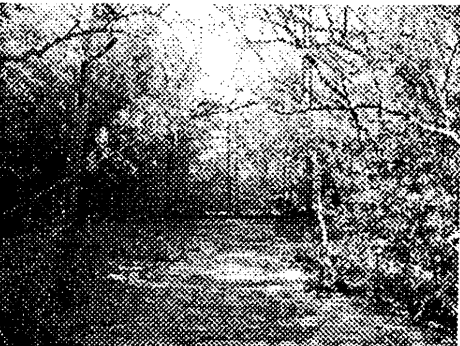
- 19. Detail of wooden bench structure. A second bench is in the background.
- 20. Final steps to Pavilion. Another wooden bench is to the left and should be replaced.
- 21. Landing at Pavilion. Concrete cracked.
- 22. Pathway to Skyride site. Railing to the left is not historic.
- 23. Steps up to Skyride. Limestone bands with asphalt. Asphalt is not historic.
- 24. Fence around Skyride site.

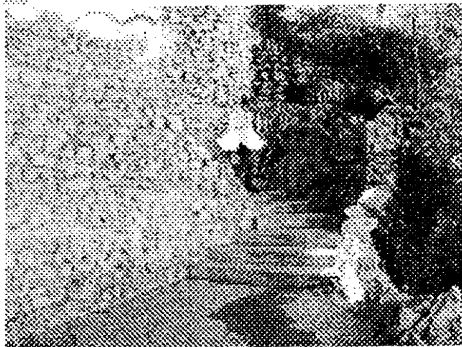
27

27. Stairs down to landing. The stairs are in good condition, however, they are not sympathetic to historic construction.

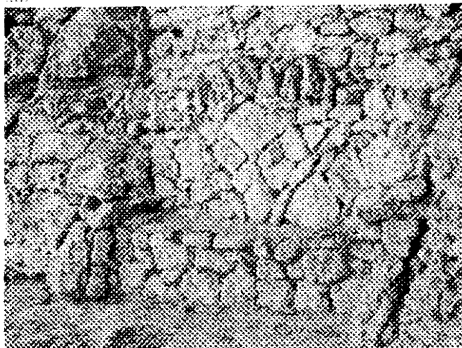
28

28. Limestone bench built into the wall at the lower level of the Pavilion. The bench is in good condition. Protect historic bench in place.

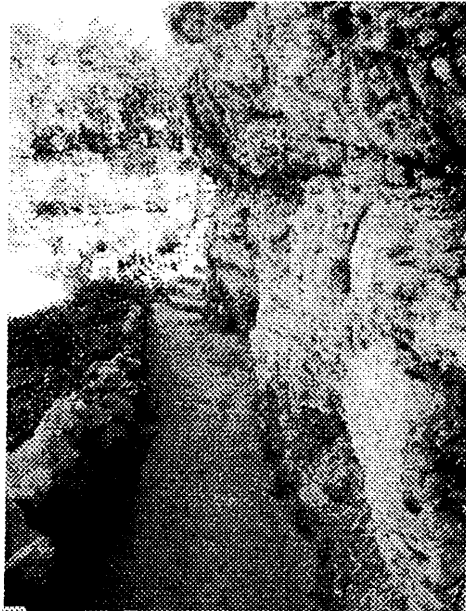
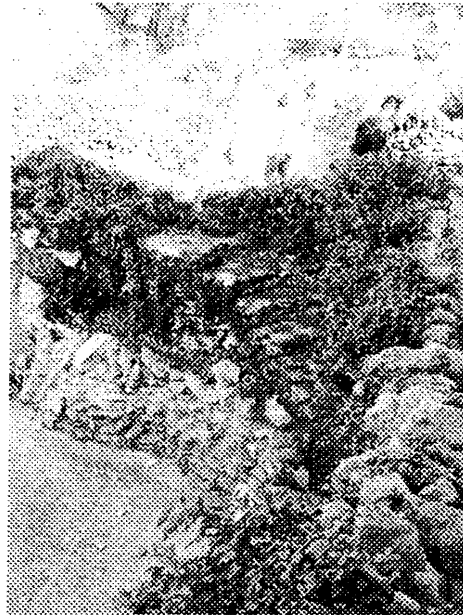
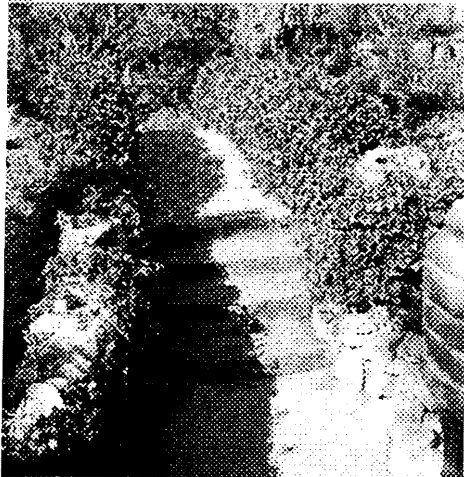
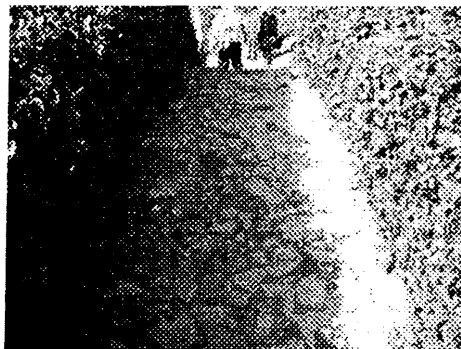
- 30. Walkway below Pavilion. Asphalt is not historic and should be removed.
- 31. Hidden steps in Pavilion pond.
- 32. Steps to arched bridge near Pavilion. Historic steps were likely limestone. Arched bridge covered with fig ivy. The ivy should be removed to expose the stone masonry.
- 33. Flagstone limestone paving on arched bridge near Pavilion.

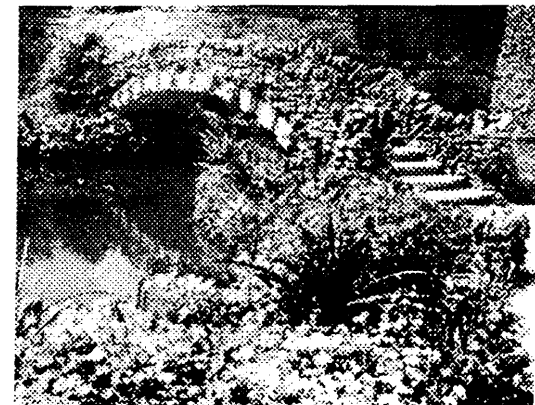
Historic image of Arched Bridge. Steps were historically large slabs of limestone, rather than concrete as they are today. It is not clear if the limestone flagstone at the curved portion of the bridge is historic. It does however, resemble the flagstone used on the Core Island.

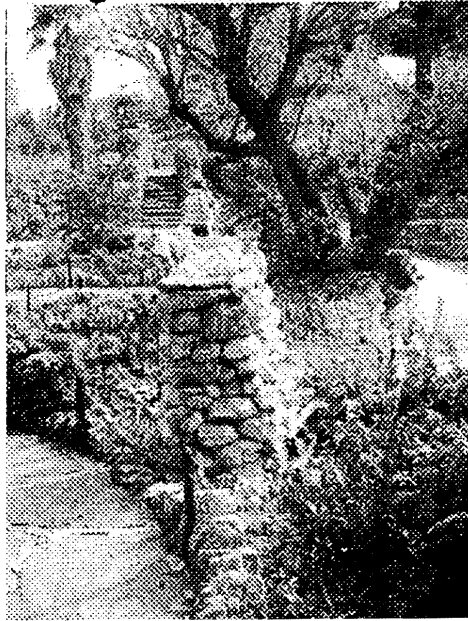
40

- 40. Pylon with missing cap. Black rail not historic and not necessary.
- 41. Core island pathway. Black post and rail not historic and should be removed.
- 42. Pylon detail with interesting stamped concrete leaf.

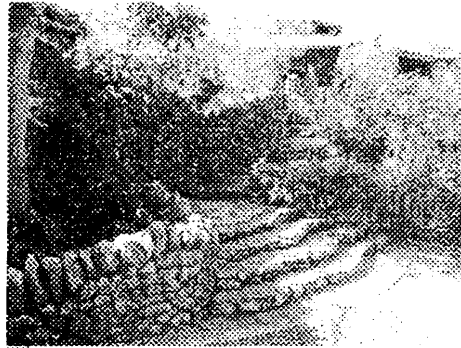
43

43. Steps up from Core Island to Pavilion. Steps are made of rock and concrete/asphalt. The steps were also large slabs of limestone rather than the stacked limestone with concrete veneer. See historic appendix images 2, 5, and 6.

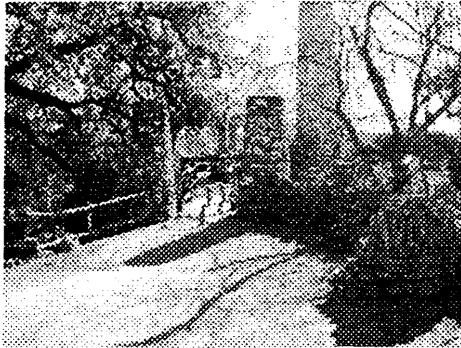
49

- 49. Historic pylons at Pavilion level marking Scenic Overlook Bridge.
- 50. Historic limestone bench built into wall. Protect historic bench in place.
- 51. Pedestrian path to zoo entry. Asphalt is not historic and should be removed.
- 52. Limestone bench built into wall. Protect historic bench in place.
- 53. Limestone path with limestone header wall around planting bed. This area has been reconfigured to accommodate the accessible bridge. See historic appendix, image 1 and 6.

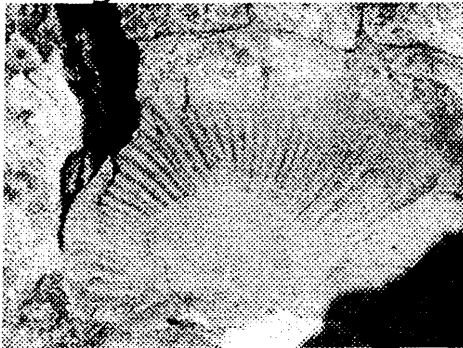
54

- 54. Historic detail on bench seat. Protect historic bench in place.
- 55. Lower level pathway. This area has been reconfigured to accommodate the accessible bridge. See historic appendix, image 1 and 6. Asphalt not historic.
- 56. Lower level pathway.
- 57. Lower level pathway. Cracked pathway.
- 58. Lower level pathway.
- 59. Lower level pathway.

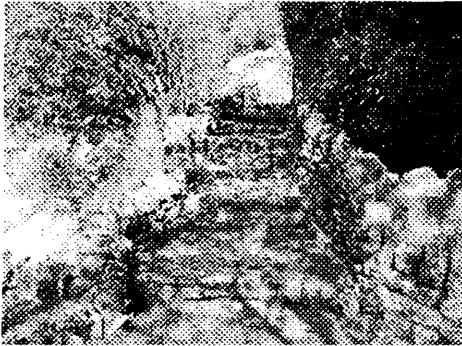
60

- 60. Steps at lower level path. Asphalt is not historic and should be removed.
- 61. Asphalt path at upper level. Asphalt is not historic and should be removed.
- 62. Asphalt pathway at upper level. Asphalt is not historic and should be removed.
- 63. Pathway and walls and upper level. Walls are in good condition. Asphalt pathway is not historic and should be removed.
- 64. Concrete pathway and planting beds. The pathway is cracked and not likely a historic material.
- 65. Limestone stairs. Stairs are in good condition.

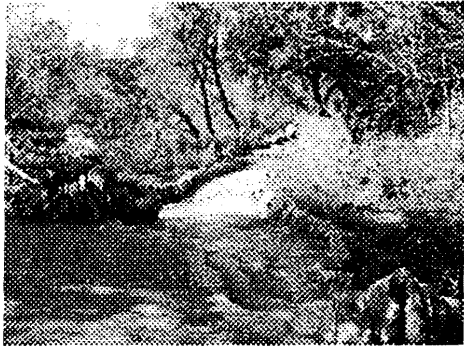
66

- 66. Landing, stairs and pathway at upper level. Asphalt is not historic material and should be replaced.
- 67. Pathway at upper level. Limestone header walls edge planting beds. Asphalt is not historic and should be replaced.
- 68. Pathway, walls and planter header at upper level. Asphalt is not historic and should be replaced.
- 69. Historic bench built into wall. Protect historic bench in place.
- 70. Stair & wall at upper level.
- 71. Stair at upper level. Asphalt is not historic and should be replaced.

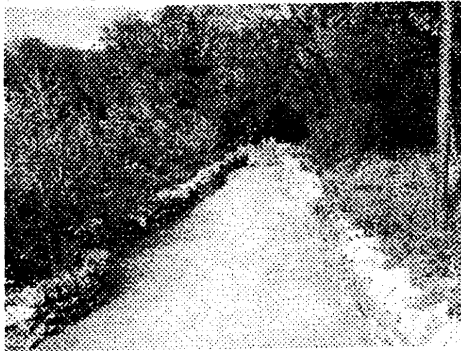
72

- 72. Pathway at upper level. Asphalt is not historic and should be replaced. Wall in good condition.
- 73. Pathway & wall at upper level pathway. Asphalt is not historic and should be replaced.
- 74. Pathway & wall at upper level. Asphalt is not historic and should be replaced.
- 75. Pathway & wall at upper level. Asphalt is not historic and should be replaced.
- 76. Stair at upper level.
- 77. Stair down to lower level.

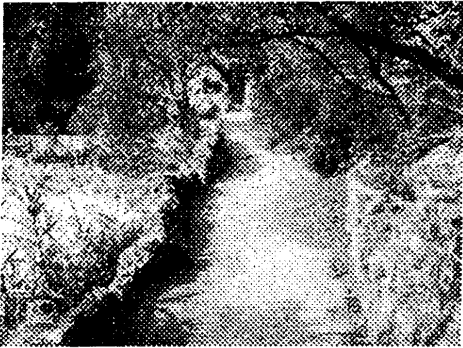
78

- 78. Lower level path. Asphalt is not historic and should be replaced.
- 79. Lower level walls & pathway. Pathway is decomposed granite, which was a common material used throughout much of the park. The path has not been maintained. It should be reconstructed.

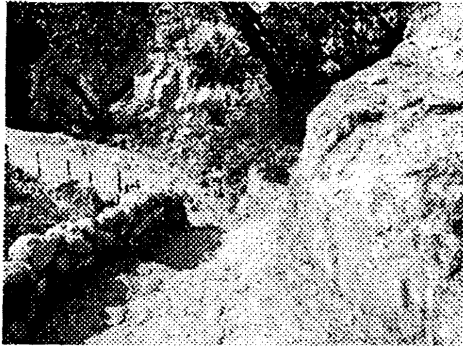
80

- 80. Pathway to waterfall. The lower wall in front of the waterfall is not historic. Historically, there were two levels of paths in front of the quarry wall, which is to the right of the image. Pathway is flagstone pavers. See historic appendix, image 1 and 6.

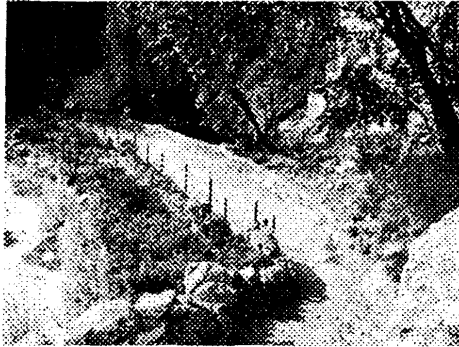
81

- 81. Pathway and walls in front of waterfall. The lower wall in front of the waterfall is not historic. Historically, there were two levels of paths in front of the quarry wall, which is to the right of the image. Black rail and chain is not historic and should be removed. The area in front of the black rail and chain was actually a path at the pond level and should be restored. See historic appendix, image 1 and 6.

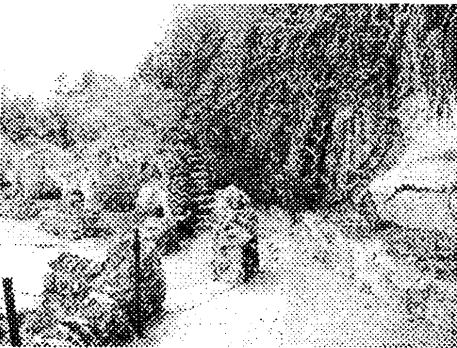
82

- 82. Pathway at waterfall. Asphalt is not historic and should be removed. Historic pylon should be protected. See historic appendix, image 1 and 6.
- 83. Steps up to dragon bridge from waterfall. Historically, these steps were carved limestone slabs.

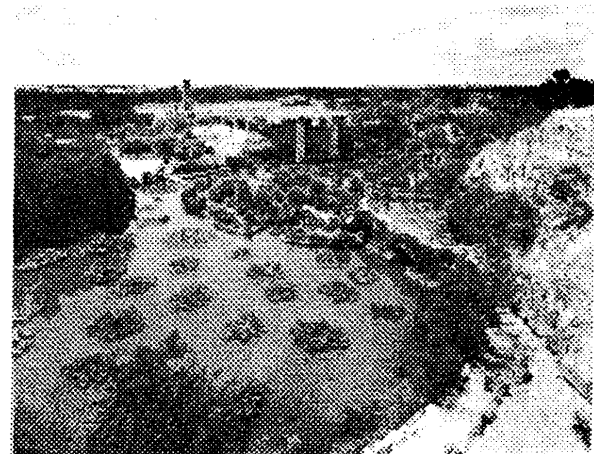
Historic image 6. Note two paths in lower right hand corner. The path was dirt, likely crushed limestone. Steps to Dragon Bridge are carved limestone. They were likely filled in with concrete over the years.

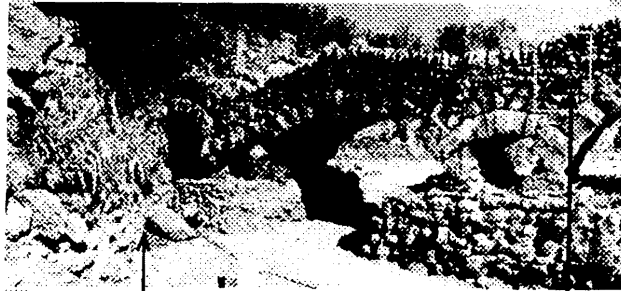
86

COMPROMISING STONE CAP WALL  
IMPACTED BY ROCK SLIDES.

- 86. Bridge accent stone missing in several areas. Replace with like stone. Remove residual fig ivy vine roots from bridge face. Fig Ivy was not an historic planting treatment and should not be allowed to grow back. The bridge is a helpful barrier in stopping the invasive and overgrown cane.

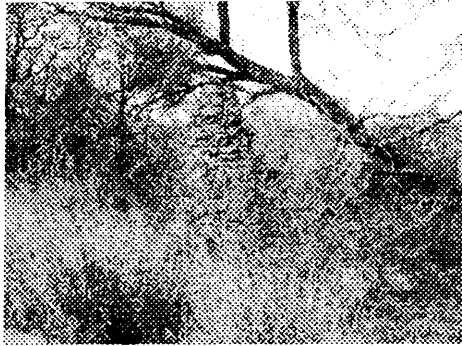
88

- 88. Historic pylon on Alpine Drive. Pylons were light structures. Clear vegetation and restore lighting to pylon.
- 89. Pylons were light structures. Pylon deteriorated and should be restored. Clear vegetation and restore lighting to pylon.
- 90. Historic pylon on Alpine Drive. Clear vegetation and restore lighting to pylon.
- 91. Historic pylon on Alpine Drive. Pylons were light structures. Clear vegetation and restore lighting to pylon.
- 92. Historic pylon on Alpine Drive. Clear vegetation and restore lighting to pylon.
- 93. Historic pylon on Alpine Drive. Pylons were light structures. Clear vegetation and restore lighting to pylon.

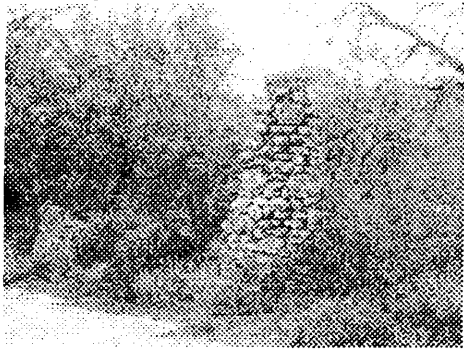
94

- 94. Historic pylon along Alpine Drive. Pylons were lighting structures. Clear vegetation and restore lighting to pylon.
- 95. Wall along Alpine Drive.
- 96. Base of wall and clearing in #93.
- 97. Steps down to scenic overlook on Alpine Drive.
- 98. Pathway at Alpine Drive scenic overlook. Asphalt not historic and should be removed.
- 99. Limestone steps at scenic overlook along Alpine Drive.

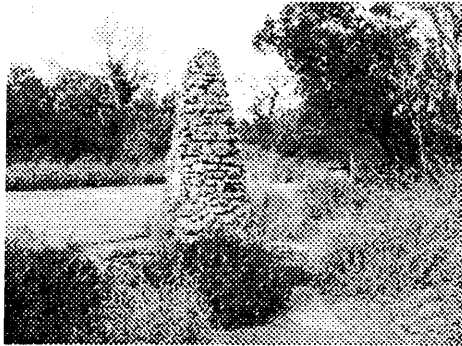
100

- 100. Historic pylon on Alpine Drive at scenic overlook. Pylons were traditionally lighting structures. Vegetation should be cleared to allow pylon to read.
- 101. Historic pylon along Alpine Drive. Pylons were traditionally lighting structures. Vegetation should be cleared to allow pylon to read.
- 102. Historic pylon along Alpine Drive. Pylons were traditionally lighting structures. Vegetation should be cleared to allow pylon to read.
- 103. Historic pylon along Alpine Drive. Pylons were traditionally lighting structures. Vegetation should be cleared to allow pylon to read.
- 104. Historic pylon along Alpine Drive. Pylons were traditionally lighting structures. Vegetation should be cleared to allow pylon to read.
- 105. Historic pylon along Alpine Drive. Pylons were traditionally lighting structures. Vegetation should be cleared to allow pylon to read.

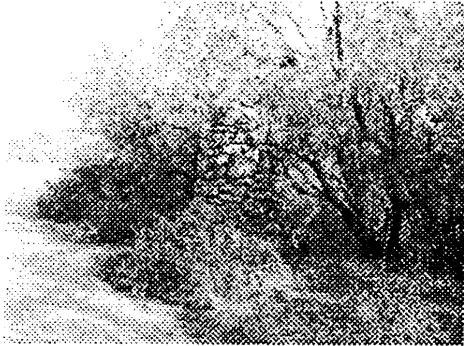
106

- 106. Historic pylon along Alpine Drive. Pylons were traditionally lighting structures. Vegetation should be cleared to allow pylon to read.
- 107. Historic pylon along Alpine Drive. Pylons were traditionally lighting structures. Vegetation should be cleared to allow pylon to read.
- 108. Foundation for Skyride. The Skyride dates later than period of significance and should be removed.
- 109. Historic pylon along Alpine Drive. Pylons were traditionally lighting structures. Vegetation should be cleared to allow pylon to read.
- 110. Historic pylon along Alpine Drive. Pylons were traditionally lighting structures. Vegetation should be cleared to allow pylon to read.
- 111. Historic pylon along Alpine Drive. Pylons were traditionally lighting structures. Vegetation should be cleared to allow pylon to read.

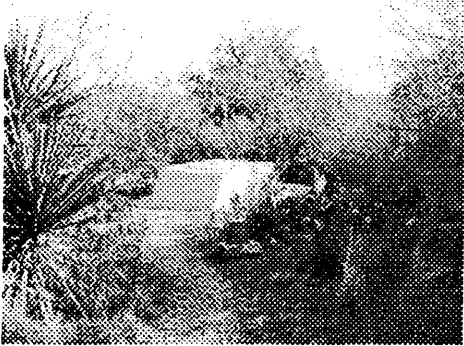
112

112. Foundation for Skyride. The Skyride dates later than period of significance and should be removed.

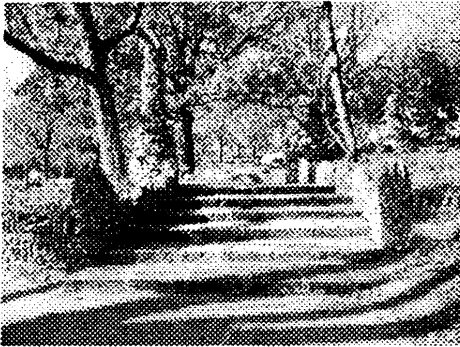
1

1. Entry along St. Mary's. The pylon height varies on either side of the stair. The two first pylons have an interesting cap detail that is relevant for new pylon construction or reconstruction. A short wall with stone cap runs along the park side, but is absent along the Mexican Village side. The paving is flagstone limestone with wide joints.

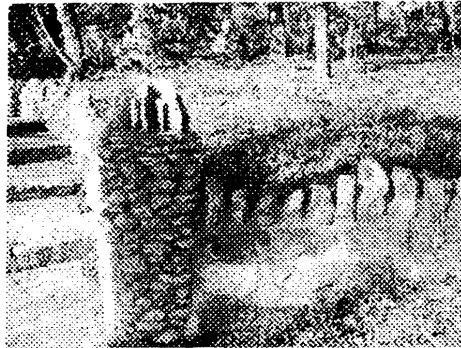
2. Stone cap missing. Replace and match surrounding cap stone size.
3. Historic pylon cap missing. See image 2 for correct cap detail.
4. Pylon with light fixture. Fixture not historically accurate. Protective covering will probably be necessary in to protect the proposed light fixtures.
5. Stone cap missing. Replace and match surrounding cap stone size.
6. Wall cracked. Replace wall as necessary.

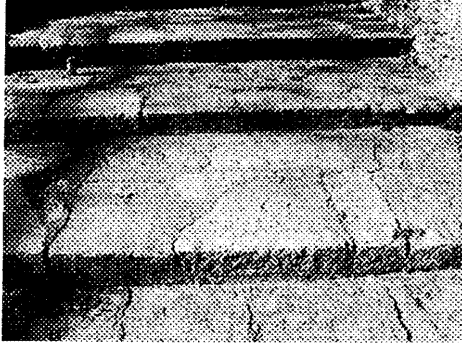
7

7. Typical limestone flagstone paving at Mexican Village entry along St. Mary's Street. Stair is in good condition.
8. Limestone edging along St. Mary's entry.
9. Limestone stair at Mexican Village Entry along St. Mary's Street. Concrete is cracked.  
Replace concrete as necessary.
10. Limestone wall at Mexican Village entry. The wall is cracked.  
Replace wall as necessary.
11. Brick path at Mexican Village casitas. The path connects the landing around the casitas to the drive. Brick was not used elsewhere in the gardens and should be replaced with limestone flagstone.
12. Covered well at Mexican Village, date unknown. The well is currently covered, but contains trash and should be cleaned out.

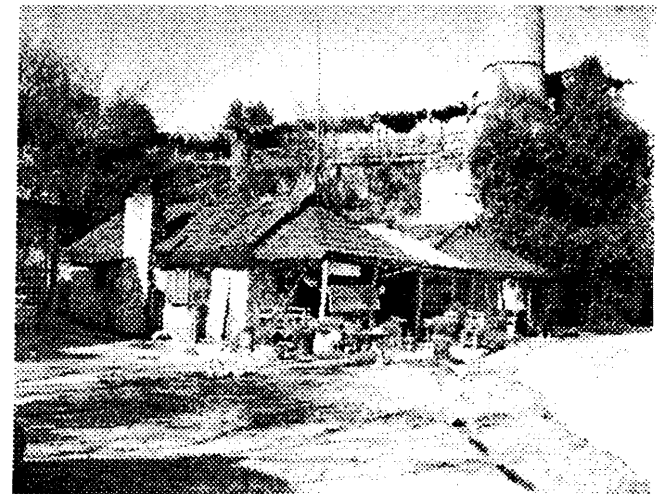
Historic image 12 shows the Mexican Village Casitas. Most of the paving was decompose granite gravel or limestone.

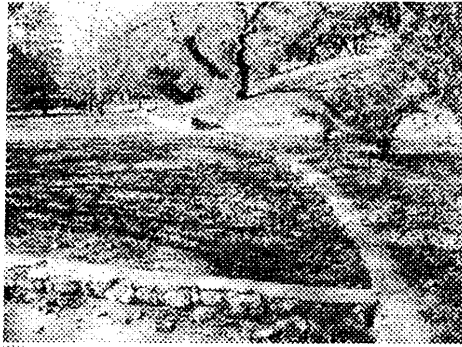
13

13. Stone wall running through landscape near Mexican Village.
14. Limestone flagstone at Mexican Village pathway to Main Entrance level. The paving is cracked and stones are loose or missing in areas. Secure loose limestone pavers and fix path as necessary. This pattern should be used to delineate areas of high foot traffic or major pathways.
15. Stair from Mexican Village Parking lot to Mexican Village casitas.
16. Stair from Mexican Village casitas to Main Entry level.
17. Tree impacting stone cap & header wall above Mexican Village casitas. Remove tree. The City of San Antonio does not generally support the removal of trees on the property. All trees to be removed should be evaluated for aesthetics, safety, health, etc. by various City staff, the consultants, and contractors involved in Master Plan implementation to determine the best for the facility.

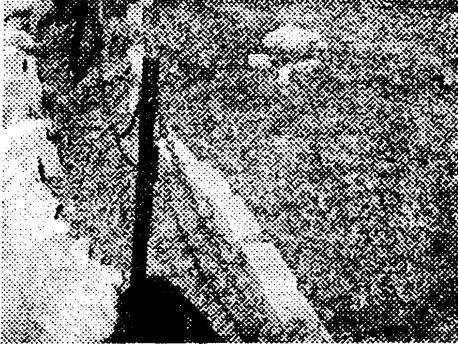
19

19. Concrete edging along path above Mexican Village. The concrete edging is not historic and should be removed.
20. Limestone cap missing and should be replaced.
21. Limestone cap missing and should be replaced.
22. Concrete path above Mexican Village. Path is cracked. Repair path as necessary.
23. Detail of cracked path.
24. Asphalt accessible path above Mexican Village. Asphalt is not historic material and should be removed. This route will need to remain accessible.

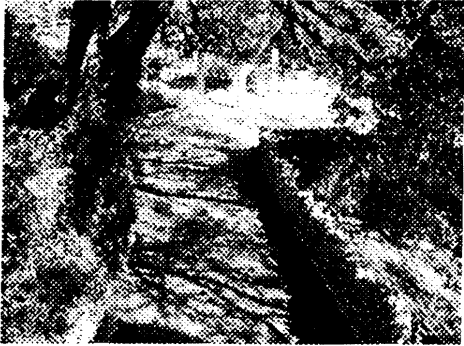
25

- 25. Accessible path above Mexican Village. Limestone walls separate planting beds and are in good shape. Asphalt is not historic and should be removed.
- 26. Accessible path above Mexican Village. This view is from the current Blue Pavilion Gate.
- 27. Planting beds framed by limestone walls near Blue Pavilion entry. Walls were recently reconstructed and are in good condition. The cap detail is not historic and should reference existing historic site walls.

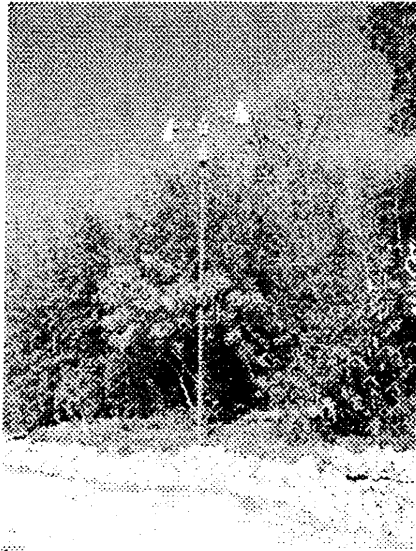
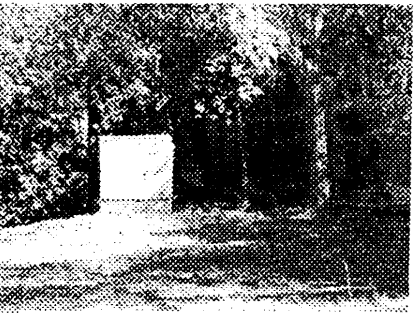
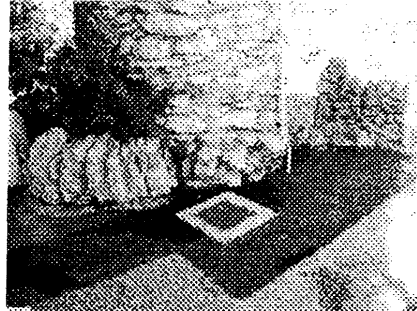
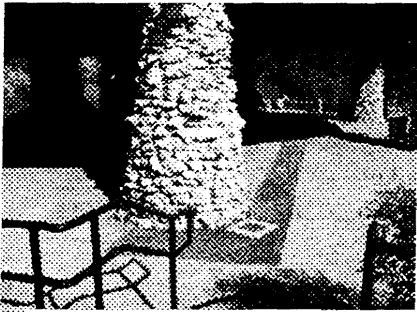
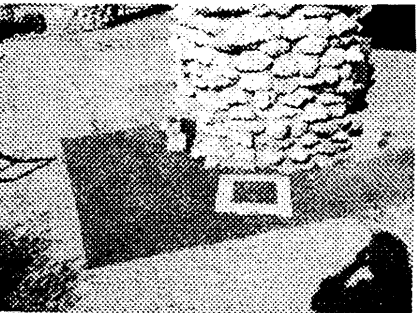
1. Outdated light pole near Main entry. Replace light pole with updated light standard.
2. New electrical power outlet at the base of the Pavilion pylons.
3. New electrical power outlet at the base of the Pavilion pylons.
4. Electric transformer near accessible ramp. Hide electrical panel with landscaping.
5. New electrical power outlet at the base of the Pavilion pylons.

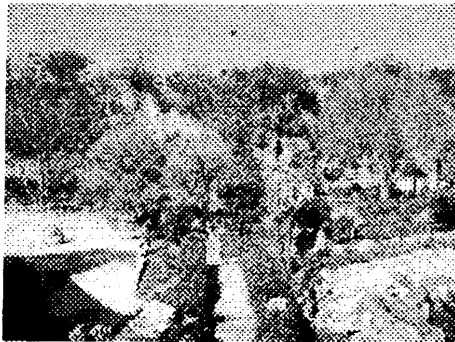
12

12. Views of Alpine Drive from the Core Garden. Lights are visible and not attractive. The lights should be removed and replaced with less obtrusive lighting.
13. Another view of Alpine drive from the Core Garden with the lights visible. The lights should be removed and replaced with less obtrusive lighting.
14. Lights under the Zoo Path Bridge. Replace any unused lighting.
15. Lights under the Zoo Path Bridge. Replace any unused lighting.
16. Uplight in planting bed. Not in use. The light fixture is obtrusive and should be replaced with a more discreet light, preferably one that is flush or easily hidden by planting.
17. Existing uplight not in use. Replace any unused lighting as necessary.

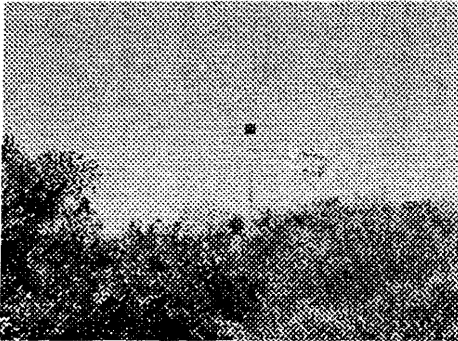
18

18. Overhead lights on Alpine Line are visible from the Core Garden. These lights are unattractive and should be replaced with a more suitable light.
19. Conduit begins in the pond planting beds near the Arched Bridge. Unused conduit should be removed. New conduit should be placed so it not noticeable.

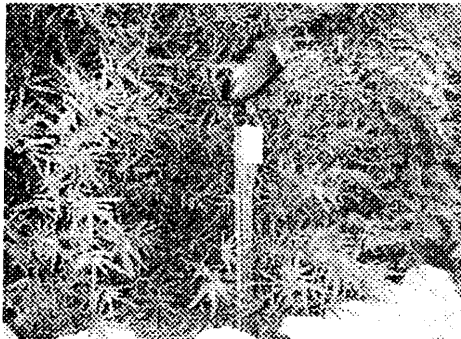
20

20. Uplights at Pavilion pond wall. Lights do not work and are missing significant parts. Lights should be replaced and future lights should be hidden in planting or buried underground.

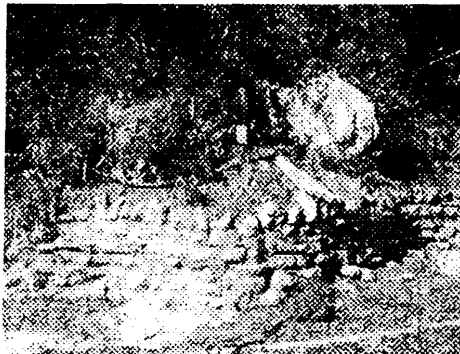
22

22. Uplights at Pavilion pond wall. Lights do not work and are missing significant parts. Lights should be replaced and future lights should be hidden in planting or buried underground.

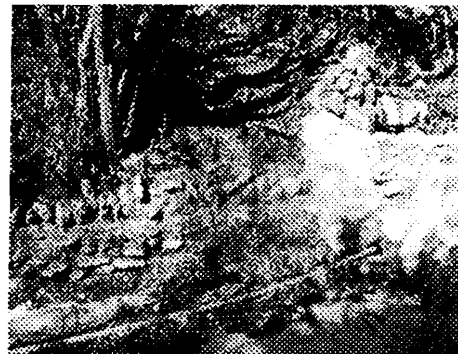
23

23. Conduit from Pavilion pond goes through the slot in the weir to the Old Quarry pond. All unused or damaged conduit should be removed.

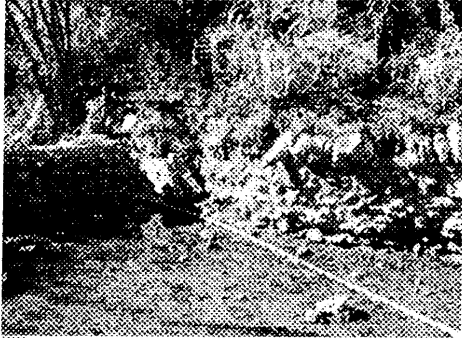
24

24. Conduit running through weir to Quarry Pond. All unused or damaged conduit should be removed.
25. Uplights in planting bed near Dragon Bridge. Lights do not work and are missing significant parts. Lights should be replaced and future lights should be hidden in planting or buried underground.

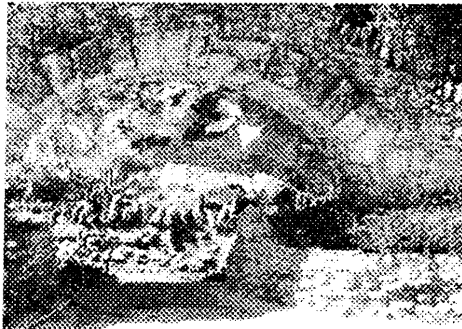
26

26. Conduit to junction box behind Dragon Bridge. Box is not functioning and missing significant pieces. Junction box should be replaced and future junction boxes should be hidden in the planting. Conduit from this junction box runs across the pond floor to the junction box at the Core Island.

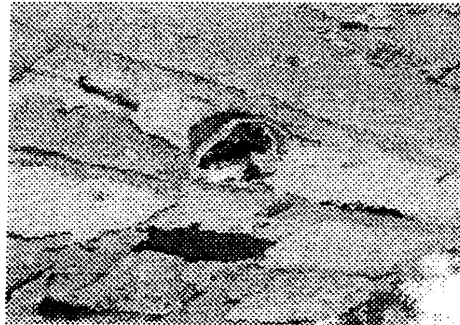
27

27. Missing lighting underneath Dragon Bridge. Historic images do not show lighting underneath the bridge. (see historic appendix, image 13, 39, and 42).

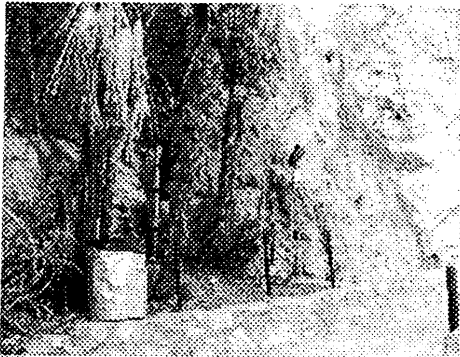
28

28. Uplights at Old Quarry wall. Lights do not work and are missing significant parts. Lights should be replaced and future lights should be hidden in planting or buried underground.

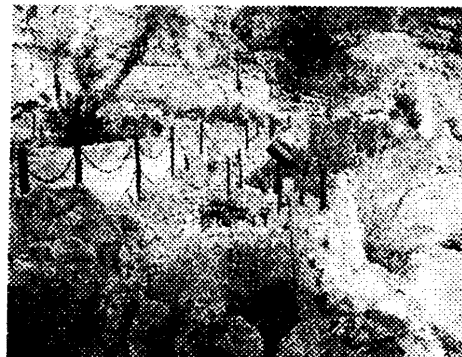
29

29. Uplights at Old Quarry wall. Lights do not work and are missing significant parts. Lights should be replaced and future lights should be hidden in planting or buried underground.
