AN ORDINANCE      2008 - 01 - 31 - 0085

**APPROVING A MASTER PLAN FOR THE JAPANESE TEA GARDEN IN BRACKENRIDGE PARK DEVELOPED IN COOPERATION WITH THE SAN ANTONIO PARKS FOUNDATION, AND THE FRIENDS OF THE PARKS.**

existing conditions :: limit of work

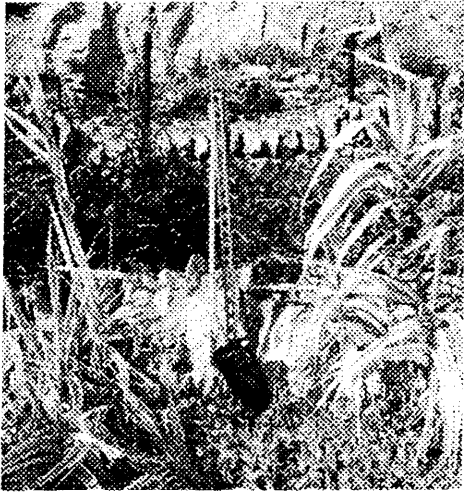
- 30. Uplight at Old Quarry wall. Light does not work and is missing significant parts. Light should be replaced and future lights should be hidden in planting or buried underground.
- 31. Water line and pumps at quarry pond. Abandoned systems should be removed. If systems are necessary, they should be hidden from visitor views and accessibility.
- 32. Water line from Alpine Drive to quarry pond. Line is obtrusive. If the water line is necessary, it should be hidden in planting. If it is not necessary, it should be removed. Existing pipe will likely need to be replaced.
- 33. Electrical panel and pump in quarry pond. All electrical and mechanical systems should be hidden and not accessible by visitors. These panels are probably not in use and should be removed.

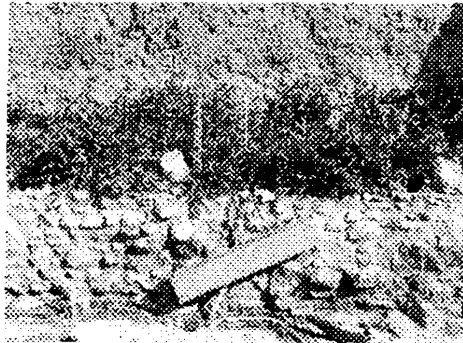
34

34. Junction box at Old Quarry wall. Box is not functioning and missing significant pieces. Junction box should be replaced and future junction boxes should be hidden in the planting. Conduit from this junction box runs across the pond floor to the junction box at the Core Island.
35. Uplights at Old Quarry wall. Lights do not work and are missing significant parts. Lights should be replaced and future lights should be hidden in planting or buried underground.
36. Historic lighting system remnant. Historic lighting should remain and could be explained if necessary.
37. Historic lighting system remnant. Historic lighting should remain and could be explained if necessary.
38. Historic lighting system remnant. Historic lighting should remain and could be explained if necessary.
39. Historic lighting system remnant. Historic lighting should remain and could be explained if necessary.

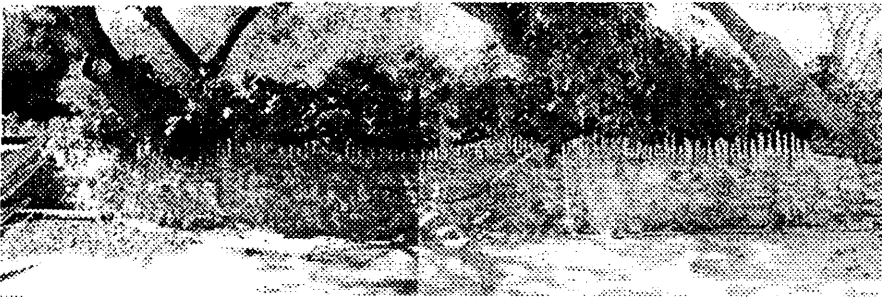
41

41. Conduit at Core Island wall in quarry pond. All conduit should be replaced and removed from visitor view and accessibility.

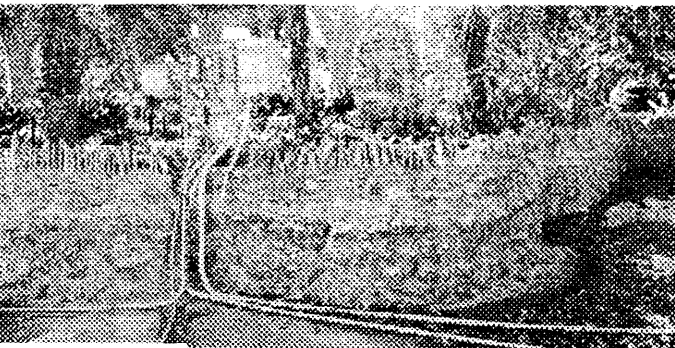
42

42. Electrical panel and conduit at Core Island wall in quarry pond. All electrical systems and conduit should be replaced and removed from visitor view and accessibility.

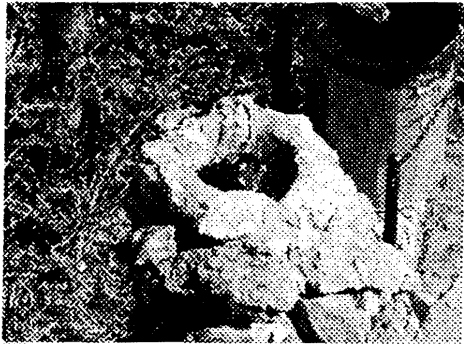
43

43. Top of historic pylon with abandoned light. There are no images of the historic pylon lighting, but it is described by Mabel Jingu in a documentary. Future lighting should recall the historic aesthetic of the gardens.

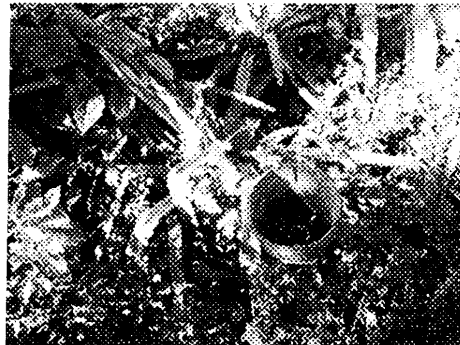
46

46. Abandoned uplight in Core Island planting bed. All abandoned lighting should be removed and replaced with lighting that is hidden in ground or in the planting bed as necessary.

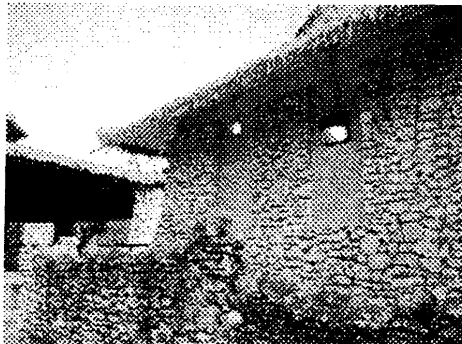
47

47. Non-historic lighting at Jingu house. These lights should be removed and replaced with historically appropriate lighting.

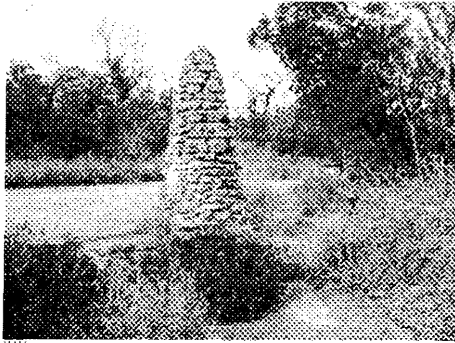
48

48. Historic pylon on Alpine Drive. The light at top is visible, but does not function. It is not clear if this lighting was present at the period of significance, but it was described by Mabel Jingu in a documentary on the gardens. All abandoned lighting should be removed and replaced with lighting that is hidden in ground or in the planting bed as necessary.

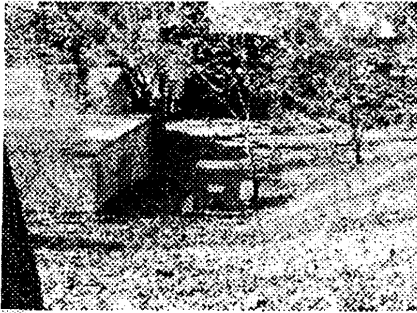
7

7. Electrical transformer behind Mexican Village Casistas. Landscape improvements should help to hide the transformer.
8. Electrical pole with ? on pole?
9. Electrical panel attached to back of the Old Kiln at Mexican Village. This panel should be relocated and removed from public access.
10. Electrical power at Mexican Village. This panel should be relocated and removed from public access.
11. Green pole near Blue Pavilion entry. New and in good condition.

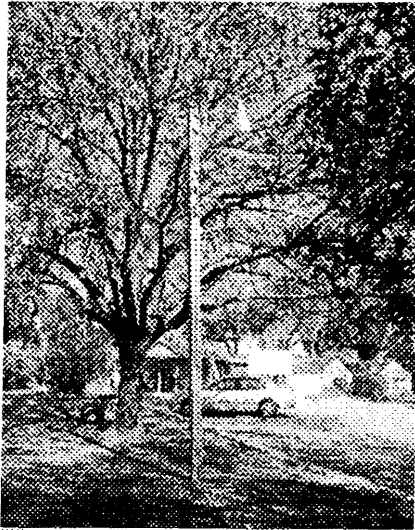
12

12. Light pole at Mexican Village Parking lot. Light pole should be replaced with standard site lighting as necessary.
13. Conduit and tree light. Tree lights should be placed in the crotch of the tree and all conduit should be painted black.
14. Conduit and tree light. Tree lights should be placed in the crotch of the tree and all conduit should be painted black.
15. Power box at base of tree in Number 14. All power boxes should either be placed in-grade or elevated above ground level at the crotch of the tree. All conduit should be painted black.

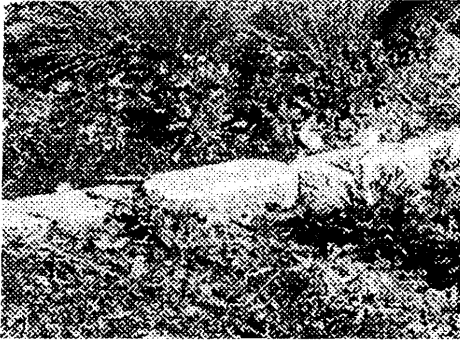
1

1. Concrete edging is not historic and should be removed.
2. Tree has been poorly pruned over the years and should be removed.
3. Planting beds are empty and should be filled with appropriate material.
4. Pylon cap detail. If planting is acceptable historic treatment, all pylons should be planted with appropriate material.
5. Tree not historic (see historic images) and should be removed. The City of San Antonio does not generally support the removal of trees on the property. All trees to be removed should be evaluated for aesthetics, safety, health, etc. by various City staff, the consultants, and contractors involved in Master Plan implementation to determine the best for the facility.
6. Cane should be removed and appropriate material planted in beds at Pavilion.

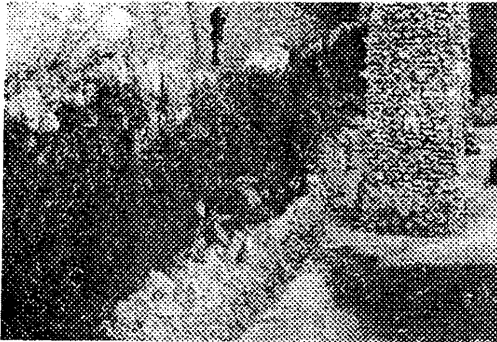
7

7. Planting bed above Pavilion pond. The vine growing on the Pavilion walls is overgrown & should be thinned out. Appropriate planting should be restored. While the banana trees are historic planting material, they are not in good shape.

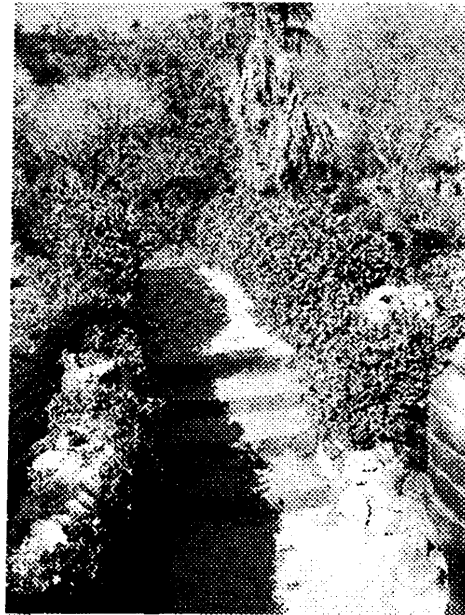
8

8. Arched bridge near Pavilion with fig ivy. Fig ivy is overgrown and not historic.
9. Planting beds on core island. Beds to the left are too tall and should contain appropriate historic plant material. Bed to the right of image is empty or missing material. Concrete edging around Lagerstroemia indica (crape myrtle) is not historic and should be removed.

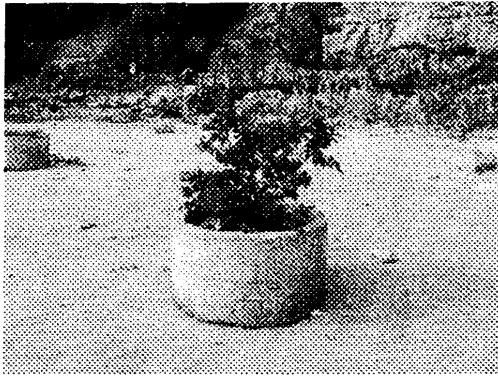
12

12. Typical planter in ponds. These planters are not from the period of significance and should be removed.
13. Empty planter beds below dragon bridge should be filled with appropriate plant material. No planting should be added to the bridge.
14. View to quarry walls & Alpine Drive. The planting should be thinned out to allow views.
15. View to garden after exiting dragon bridge. Consideration should be given to thin out the upper pathways and quarry walls.

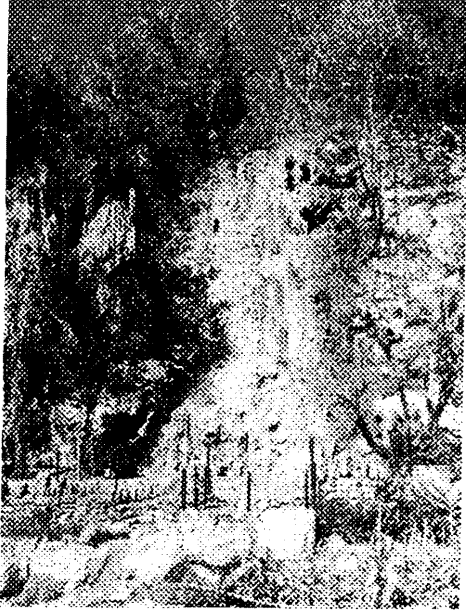
16

16. Historic waterfall covered in dried lichens and moss. It is believed this plant material will return to life once the water is restored. If necessary, file in with similar species to create the appropriate landscape effect.
17. Mid-level pathway through planter beds.
18. Planting at the upper level pathway includes more overhead canopy trees. The trees help create a distinct planting zone and should be protected.

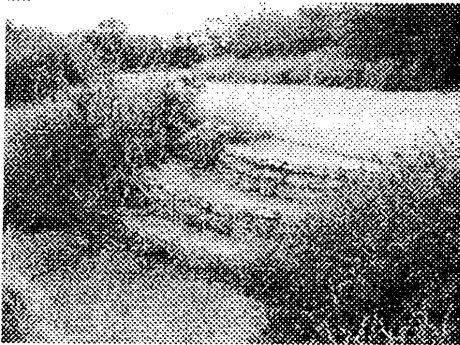
21

19. Pathway and overgrown planting along Alpine Drive. The weeds should be removed.
20. Scenic overlook along Alpine Drive. The planting has taken over the pathway and should be removed as necessary.
21. Planting next to stair at scenic overlook along Alpine Drive. While the planting next to steps are mostly weeds, the effect is desirable. It should be thinned out and contain appropriate plant material.
22. View to garden/Pavilion from scenic overlook. Overgrown trees and vegetation should be thinned to restore views from above. (See historical images, appendix).
23. View to ponds from Alpine Drive. Large crape myrtle (*lagerstroemia indica*) blocks views to Pavilion. Historically, lower planter material was used on the island.
24. Steps up from zoo entry. Understory should be thinned out.

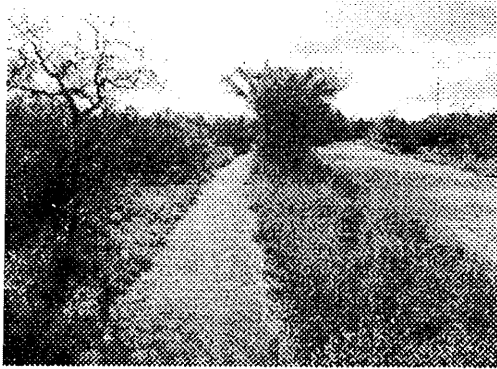
25

25. Pathway along Alpine Drive. Pathway provides walks through various plant communities. It is a great opportunity for plant and environmental education. This portion is characterized by lower grasses without much canopy.

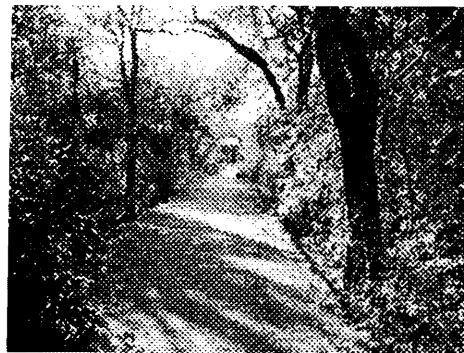
28

28. Pathway along Alpine Drive. Pathway provides walks through various plant communities. It is a great opportunity for plant and environmental education. The canopy is fully developed and the understory is very lush. It might be desirable to thin out the understory to take advantage of vistas and increase security.

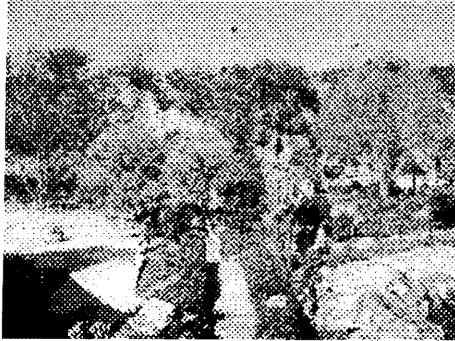
29

Trees on the core island have not been maintained or pruned over the years. They are overgrown and some towards the end of their lifespan. Some of the trees are damaging the pond walls and should be removed prior to pond restoration. However, the City of San Antonio does not generally support the removal of trees on the property. All trees to be removed should be evaluated for aesthetics, safety, health, etc. by various City staff, the consultants, and contractors involved in Master Plan implementation to determine the best for the facility.

- 29. View of overall core island canopy.
- 30. Crape myrtle (*Lagerstroemia indica*)
- 31. Coral tree (*Erythrina caffra*) causing damage to pond wall.
- 32. Coral tree (*Erythrina caffra*) causing damage to pond wall.
- 33. Trees causing damage to pond wall.
- 34. Coral tree (*Erythrina caffra*) causing damage to pond wall.

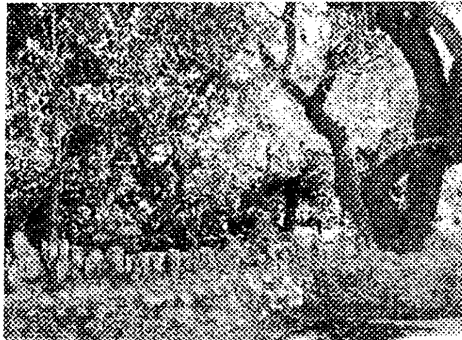
35

35. Overgrown tree near weir. The tree is causing damage to pond walls and stone cap. Tree should be removed and pond walls reconstructed with ponds restoration work. The City of San Antonio does not generally support the removal of trees on the property. All trees to be removed should be evaluated for aesthetics, safety, health, etc. by various City staff, the consultants, and contractors involved in Master Plan implementation to determine the best for the facility.

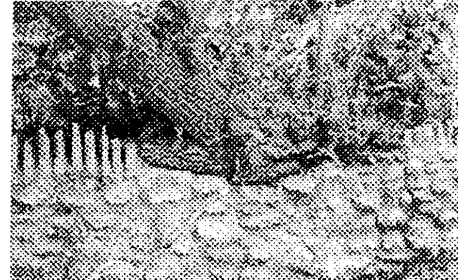
36

36. Coral tree (*Erythrina caffra*) overgrown and causing damage to pond walls and stone cap. Tree should be removed and ponds walls reconstructed with ponds restoration work. The City of San Antonio does not generally support the removal of trees on the property. All trees to be removed should be evaluated for aesthetics, safety, health, etc. by various City staff, the consultants, and contractors involved in Master Plan implementation to determine the best for the facility.

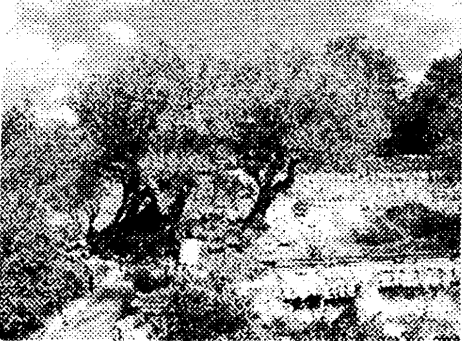
37

37. Orchid tree on central island. Tree is large and overgrown. While it doesn't cause a threat to pond walls, it should be considered for removal. The City of San Antonio does not generally support the removal of trees on the property. All trees to be removed should be evaluated for aesthetics, safety, health, etc. by various City staff, the consultants, and contractors involved in Master Plan implementation to determine the best for the facility.

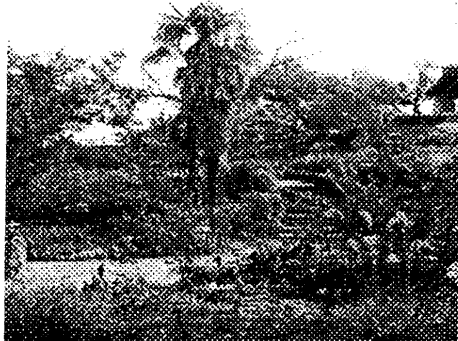
38

38. *Rhaps humilus* palm. Remove dead fronds.
39. Coral tree (*Erythrina caffra*) overgrown and causing damage to pond walls and stone cap. Tree should be removed and ponds walls reconstructed with ponds restoration work. The City of San Antonio does not generally support the removal of trees on the property. All trees to be removed should be evaluated for aesthetics, safety, health, etc. by various City staff, the consultants, and contractors involved in Master Plan implementation to determine the best for the facility.

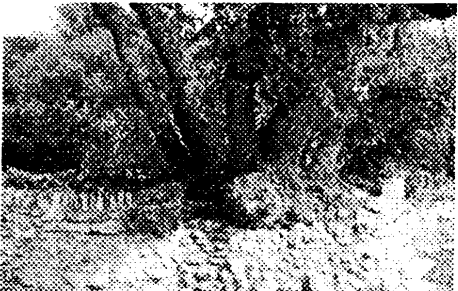
40

40. Coral tree (*Erythrina caffra*) overgrown and causing damage to pond walls and stone cap. Tree should be removed and ponds walls reconstructed with ponds restoration work. The City of San Antonio does not generally support the removal of trees on the property. All trees to be removed should be evaluated for aesthetics, safety, health, etc. by various City staff, the consultants, and contractors involved in Master Plan implementation to determine the best for the facility.

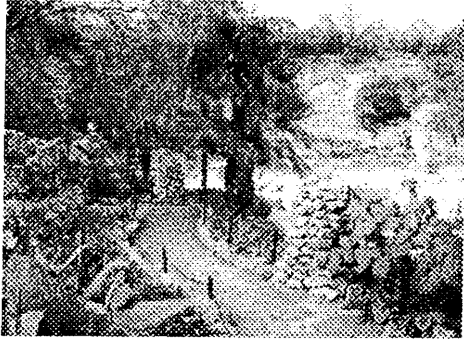
41

- 41. Tracheocypres fortunei group near electrical junction box.
- 42. Orchid tree overgrown on central island.
- 43. Rhaps humilus. Remove dead palm fronds.
- 44. Coral tree (Erythrina caffra) compromising walls at Core Garden island. In order to successfully restore the ponds, the tree should be removed. The City of San Antonio does not generally support the removal of trees on the property. All trees to be removed should be evaluated for aesthetics, safety, health, etc. by various City staff, the consultants, and contractors involved in Master Plan implementation to determine the best for the facility.

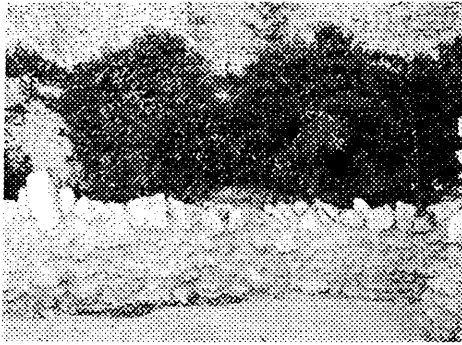
45

45. Invasive bamboo typical at Pavilion pond. It should be removed.
46. Overgrown Coral tree (*Erythrina caffra*) tree is compromising walls at Core Garden island. In order to restore the ponds, the tree should be removed. The City of San Antonio does not generally support the removal of trees on the property. All trees to be removed should be evaluated for aesthetics, safety, health, etc. by various City staff, the consultants, and contractors involved in Master Plan implementation to determine the best for the facility.

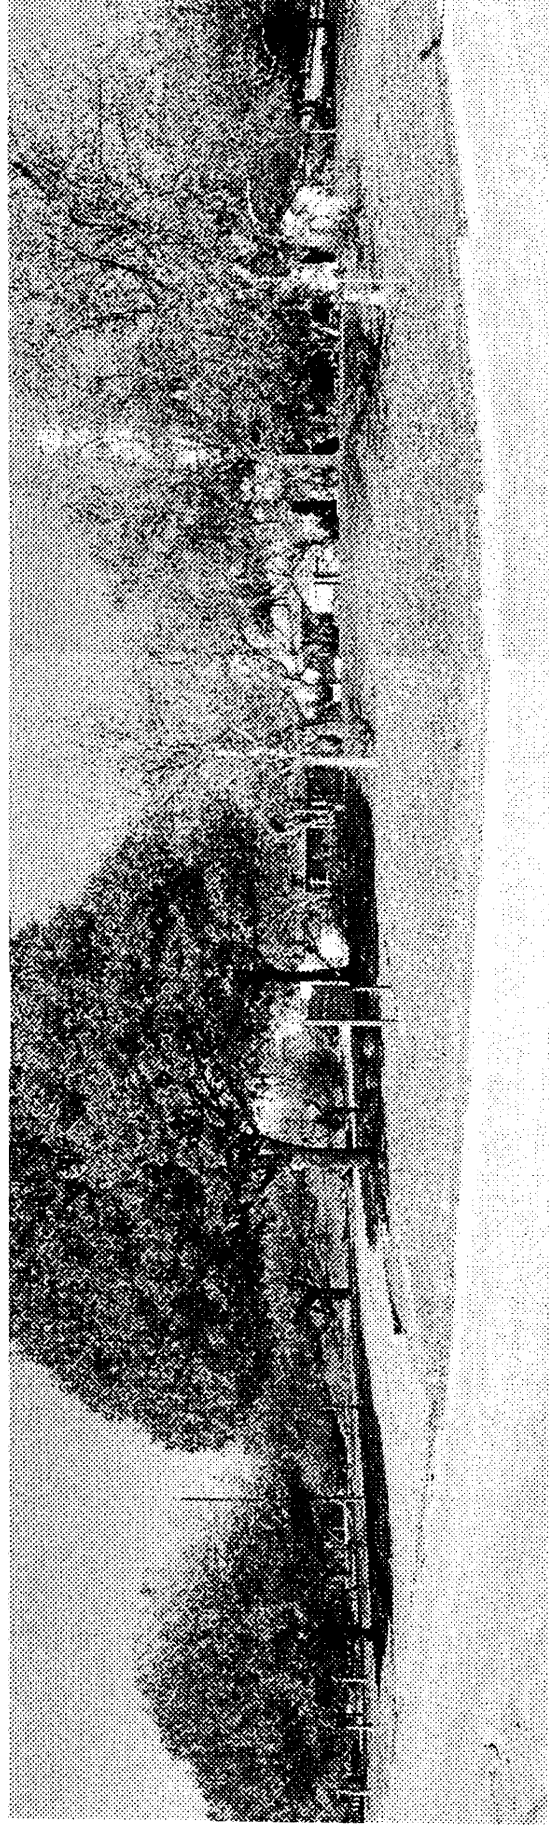
1. Canopy trees at Mexican Village.

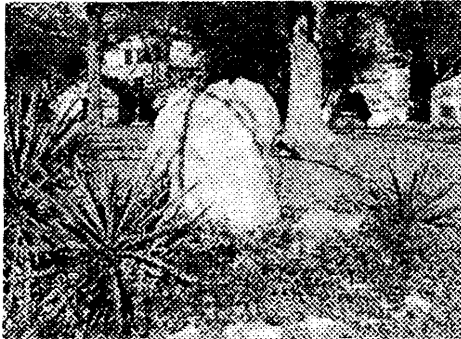
2

2. Yucca planting by quarry monument
3. The pedestrian path along St. Mary's St. ends at the stair. Path users have forged an unofficial path in front of Mexican Village. A permanent path should be considered for this location.
4. Planting beds along North side of pathway
5. Stones used as edging.
6. Planting bed next to swale. Swale is present in historic photos, but was not always concrete.
7. Planting bed at Mexican Village casitas. Planting bed is not historical.

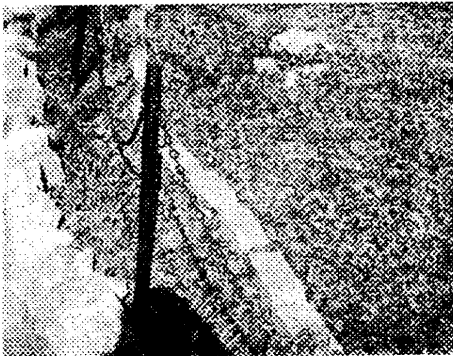
9

8. Overgrown tree at Mexican Village casitas. Remove tree.
9. Planting bed. Fill in with groundcover.
10. Vine overtaking tree. Tree to be removed. Tree should be removed and ponds walls reconstructed with ponds restoration work. The City of San Antonio does not generally support the removal of trees on the property. All trees to be removed should be evaluated for aesthetics, safety, health, etc. by various City staff, the consultants, and contractors involved in Master Plan implementation to determine the best for the facility.
11. Remove concrete edging.
12. Remove weeds from bed to North of accessible path and replace with appropriate planting material.

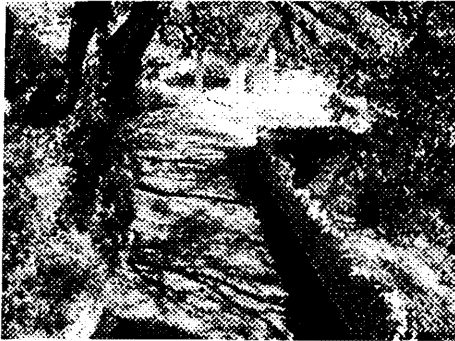
13

- 13. Shaded planting bed near Blue Pavilion entry.
- 14. Planting beds stepping up to Kiln Overlook bridge.
- 15. If city views are desirable, the pecan and red oak in front of the casitas needs to be removed. The City of San Antonio does not generally support the removal of trees on the property. All trees to be removed should be evaluated for aesthetics, safety, health, etc. by various City staff, the consultants, and contractors involved in Master Plan implementation to determine the best for the facility.

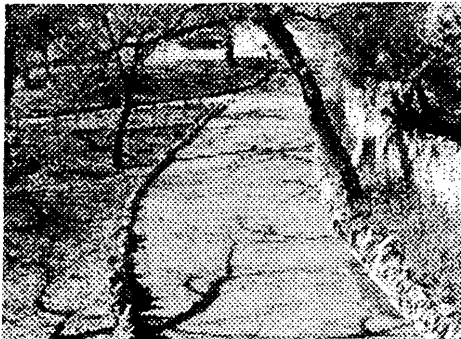
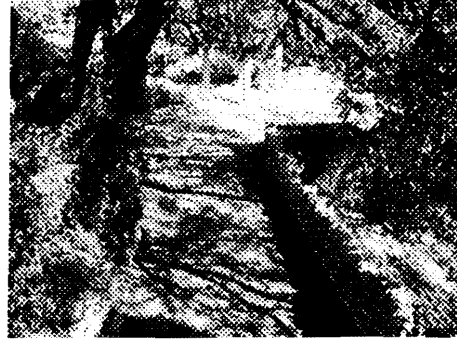
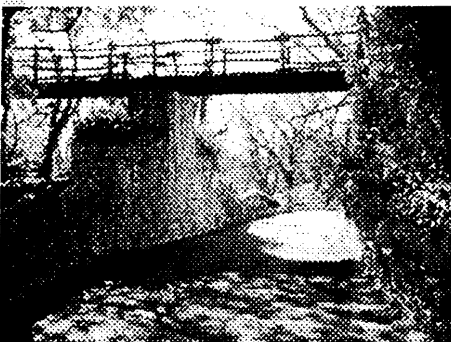
1. Accessible entry path between Mexican Village and Core Gardens. The accessible path is to one side of the large asphalt drive. Because the asphalt path is not entirely accessible, it is recommended that this path be modified in both material and design to create a central accessible path.

2. Accessible entry path between Mexican Village and Core Gardens. The accessible path is to one side of the large asphalt drive. Because the asphalt is not accessible, it is recommended that this path be modified in both material and design to create a central accessible path.

3. Accessible entry path between Mexican Village and Core Gardens. The accessible path is to one side of the large asphalt drive. Because the asphalt is not accessible, it is recommended that this path be modified in both material and design to create a central accessible path.

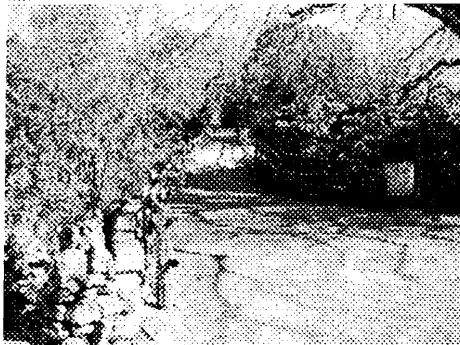
8

- 6. Chinese Tea Garden Gate
- 7. Accessible entry at Core Gardens.
- 8. Zoo entry path at Pavilion level. Security gate needed to keep people from entering the gardens from this path.
- 9. Blue Pavilion Entry. Blue Pavilion to be removed.
- 10. Vandalism on limestone.
- 11. Vandalism on kiln overlook.
- 12. Visitors entering the park through unofficial paths along the quarry walls.

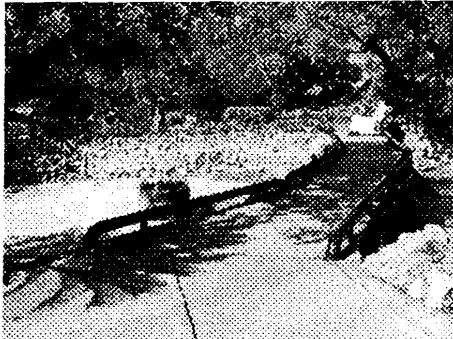
13

- 13. Accessible ramp at Core Garden Island level. The ramp is on top of the historic weir. While the weir is historic, this is the only accessible entry to the island and should be maintained.
- 14. Visitors climbing over Pavilion walls.
- 15. Unsafe drop along Alpine Drive.
- 16. Unsafe drop along Alpine Drive.
- 17. Rock slides from Alpine Drive present a problem to the pathways around the quarry pond.

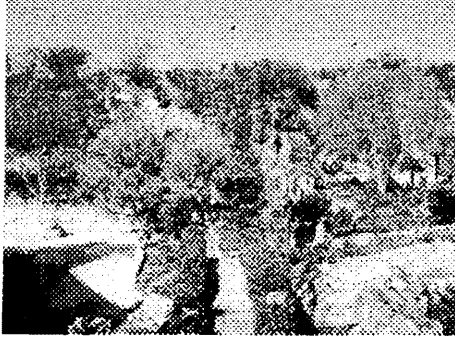
1. View from Arched Bridge to Core Island and Alpine Drive is blocked by canopy trees. Consider removing trees that block views, including the crape myrtle (*lagerstroemia indica*), orchid tree (*Bauhinia galpinii*), and coral trees (*Erythrina indica*). Clearing should also occur along Alpine Drive in order to make this historic route visible. The City of San Antonio does not generally support the removal of trees on the property. All trees to be removed should be evaluated for aesthetics, safety, health, etc. by various City staff, the consultants, and contractors involved in Master Plan Implementation to determine the best for the facility.

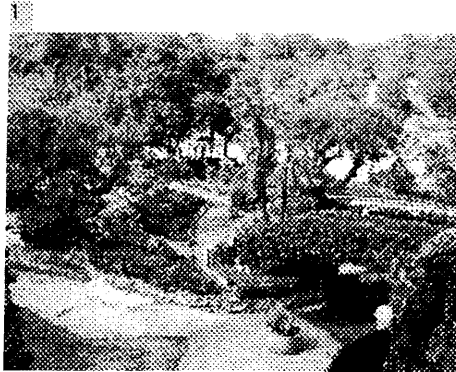
3. View from Pavilion to Core Island is blocked by trees. Consider removing trees that block views, such as the coral trees (*Erythrina indica*).
4. View from Pavilion to Core Island and Alpine Drive is blocked by canopy trees. Consider removing trees that block views, including the crape myrtle (*lagerstroemia indica*) and coral trees (*Erythrina indica*). The palms in the planting beds also block views at the pedestrian level. Clearing should also occur along Alpine Drive in order to make this historic route visible.

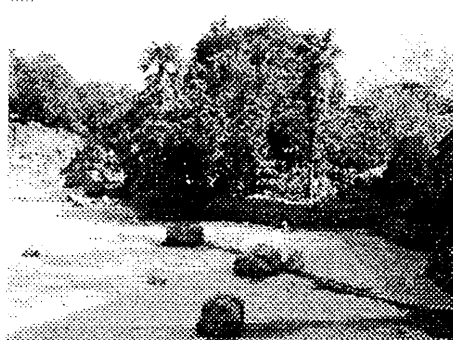
8

8. View from waterfall to Core Island. Consider removing trees that block views, including the crape myrtle (*lagerstroemia indica*) and coral trees (*Erythrina indica*). The shrubs and palms in the planting beds also block views at the pedestrian level. The City of San Antonio does not generally support the removal of trees on the property. All trees to be removed should be evaluated for aesthetics, safety, health, etc. by various City staff, the consultants, and contractors involved in Master Plan implementation to determine the best for the facility.

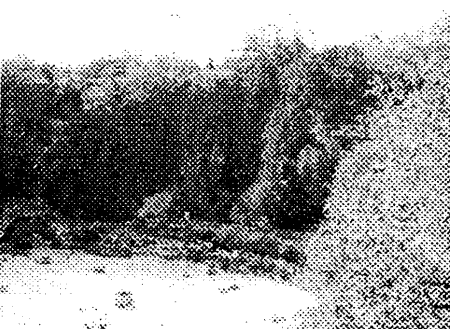
14

14. View from mid-path to waterfall and Alpine Drive.

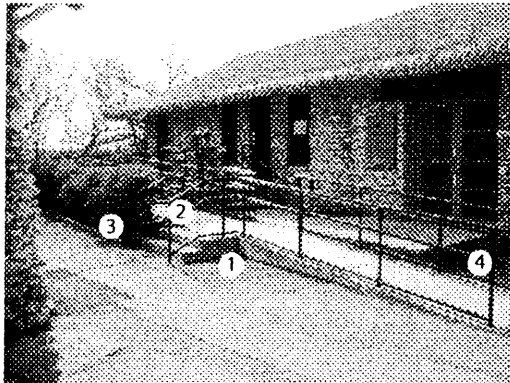
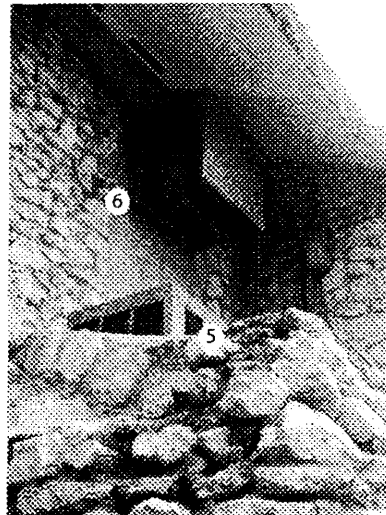
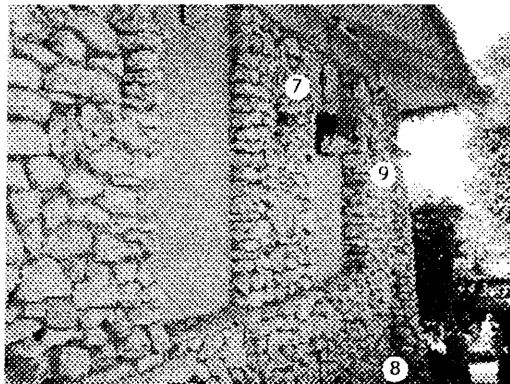
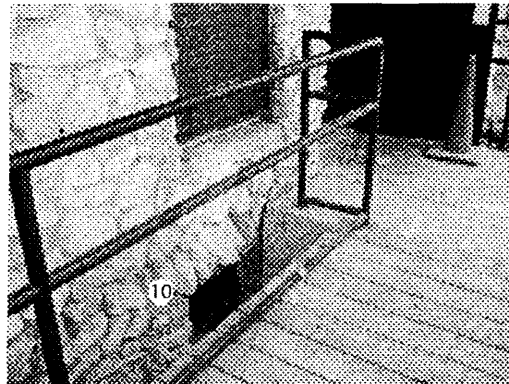
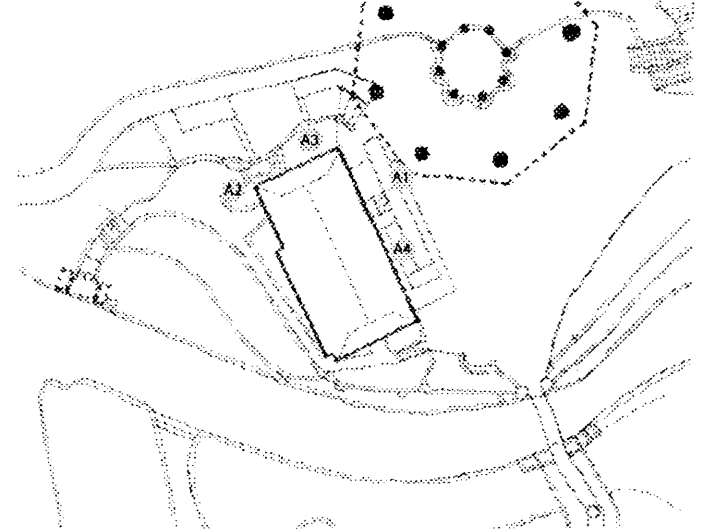
1. Accessible ramp detracts from original facade; does not meet current ADA standards. Remove and relocate ADA access.
2. Wood deck is deteriorating; nails are exposed, creeping up, typ. Remove deck and/or rebuild for necessary ADA access.
3. Open area beneath deck
4. Dropoff at landing = 10"-12"
5. New HVAC condensing unit; relocate or screen as appropriate.
6. Exposed HVAC lines; relocate or screen as appropriate.
7. Unsympathetic lighting, typ. Replace all fixtures with period appropriate placement and selections.
8. Stone masonry spalling off at corner; remove and replace deteriorating stone.
9. Infill/patched area
10. Lower transom windows are covered by concrete/landing.

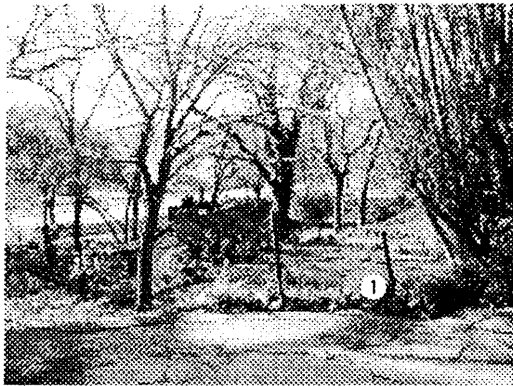
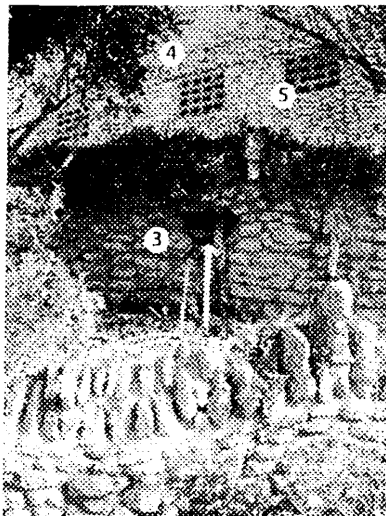
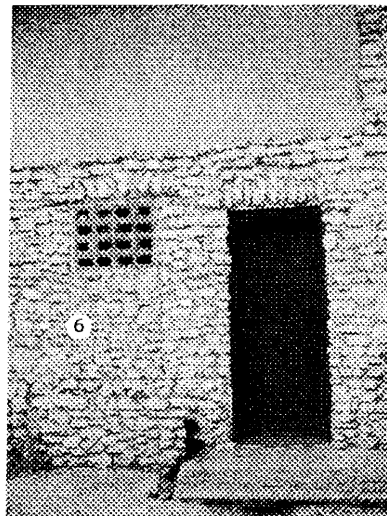
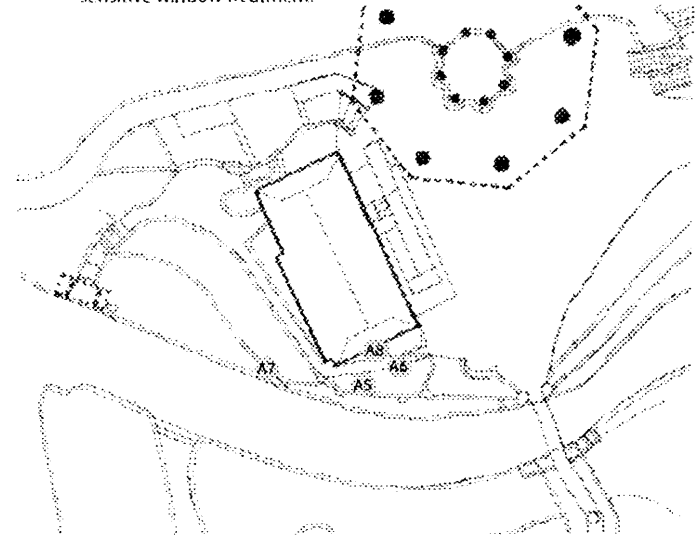
1. Railing at Southern walkway is in disrepair, presents unsafe condition. Replace railing or restrict public access to the area.
2. Exposed cleanout at rear door, walkway
3. Hose bibs/plumbing have damaged retaining walls. Repair landscape walls as necessary for stabilization and screen hose bibs.
4. Exposed wood at stucco sill; remove exposed wood at all locations and replace with stone cap or other period sensitive treatment.
5. CMU infill vents; remove (typical at all locations) and replace with period sensitive window treatment.
6. Stone infill below CMU vents, typ. Remove and replace with period sensitive window treatment.

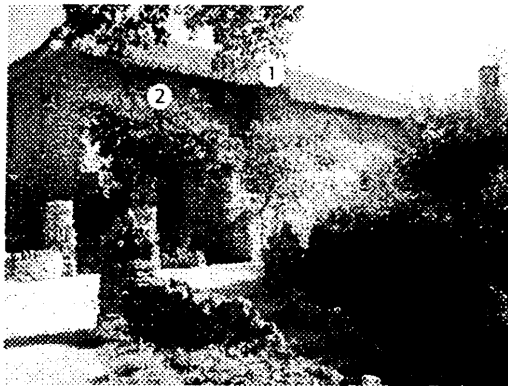
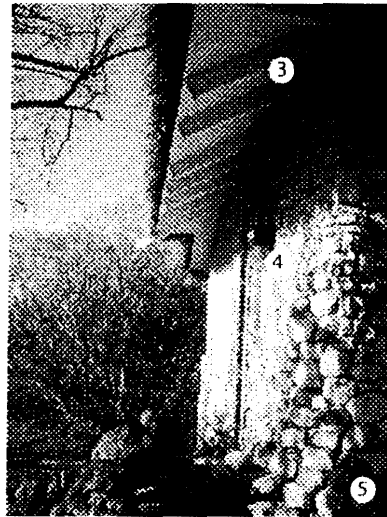
1. New (synthetic) thatched roof
2. Kitchen exhaust fans; remove or screen as appropriate for future use.
3. Roof structure and decking repaired/repainted
4. Unsympathetic lighting, typ. Replace all fixtures with period appropriate placement and selections.
5. Continuous 1/4" crack from infill wall to grade. Repoint mortar as necessary for stabilization.

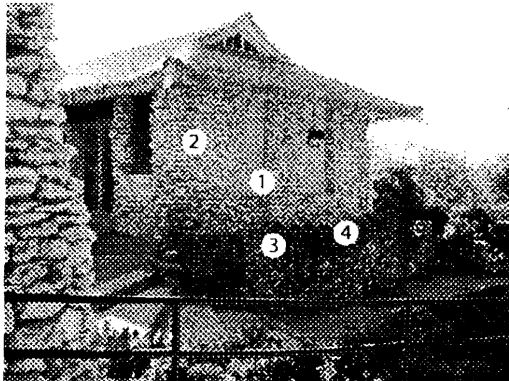
A11- Northeast corner from Pavillion

1. Stucco infill at windows; remove and replace with period sensitive window treatment.
2. Stone masonry repair area
3. Continuous vertical crack; repoint mortar as necessary.
4. Continuous horizontal crack at 2nd floor line; 3" gap at steps; assess for structural stability and repair as necessary.
5. CMU infill, typ. Remove and replace with period sensitive window treatment.
6. Security screens at windows, & transoms unsympathetic, typ. Remove and replace with period sensitive window treatment.
7. Doors and screens unsympathetic, typ. Remove and replace.
8. Stone infill does not match style of original masonry. Remove unsympathetic stone and rebuild in original style.
9. Top of stone wall deteriorated along eave line. Remove unsympathetic stone and rebuild in original style.
10. Unsympathetic stone infill below window; Remove unsympathetic stone and rebuild in original style.

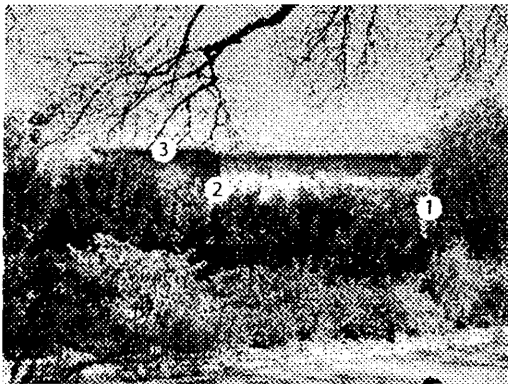
A15- West facade from road

1. Stucco panel infill at screen porch and window locations; remove and replace with period sensitive window treatment.
2. Remove, relocate, or screen exposed HVAC equipment.
3. Relocate overhead telephone lines (to underground.)
4. Stone masonry in disrepair; repair/repoint as necessary, typ. Exposed wood several locations, typ.
5. Wood door deteriorated, screen door missing. Remove and replace with period door.
6. Restroom HVAC equipment; relocate or screen as necessary.
7. Mortar cracked at screen door frames, typ. repoint mortar as necessary for stabilization.
8. Water damage, vertical crack at low stone masonry wall. Clean stone wall and repoint mortar.

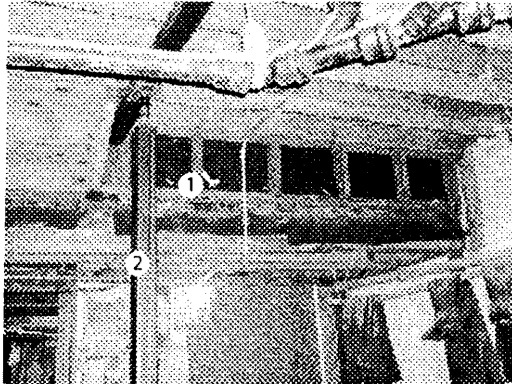
A19- Interior at first level

1. High-low ceiling condition at grade transition above (stairs from upper level are visible.)
2. New steel shoring supporting 2nd floor, typ. (Installed during restroom renovation; supported on concrete floor with wood blocking.) Future use to determine more appropriate structural reinforcement
3. Major water damage to 2nd floor structure throughout; remove and replace damaged structure
4. Window infill panels do not appear to be damproofed/waterproofed; remove infill and replace with period sensitive treatment
5. Concrete floor uneven and not level; appears to be infill without water barrier (sweating.) Relevel/rebuild floor as appropriate for future use
6. Exposed piping in poor condition, typ; clearance under pipes less than 7'-0" clear in some areas. Piping needs to be determined for future use and replaced/repared as necessary.

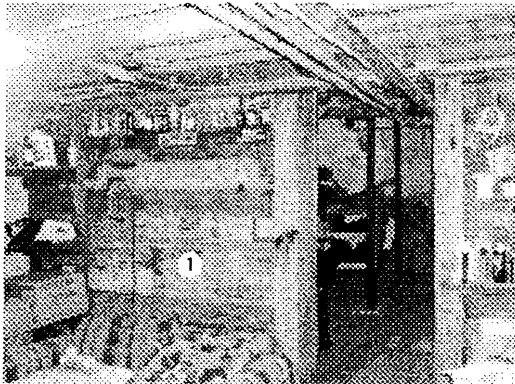
A23- Interior at first level

1. Wood batten walls deteriorated due to water damage. Future use of this level to determine level of preservation or non-historical repair (typ.)
2. Plaster walls are cracked, deteriorated, typ. Mold and water stains are present; does not appear to be waterproofed. Repair plaster, rebuild walls with adequate moisture barrier.
3. All electrical devices are exposed; some appear abandoned. Determine functional electrical service and remove nonfunctional equipment.
4. Mold/ mildew growth present at multiple locations; clean and remove mold and repair/rebuild walls as necessary.
5. Piping penetrations damaging walls. Determine needs for piping and remove or replace.

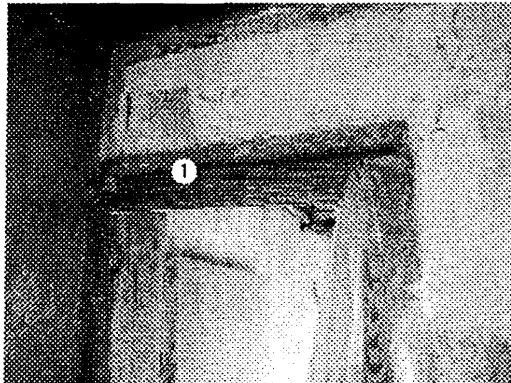
A27- Interior at first level

1. Door frames are deteriorated, wood rotted, typ. Remove and replace with period door.
2. Infill at window locations, typ; do not appear to be dampproofed/ waterproofed; remove and replace with period sensitive window treatment.
3. New patch work at West exterior wall; future use to determine level of interior wall restoration necessary.
4. Water damage at floor, typ; floor uneven. Relevel/rebuild floor as appropriate for future use.

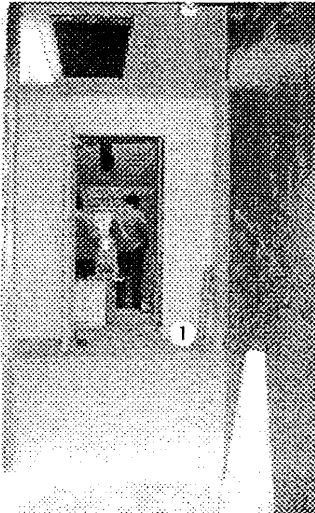
A31- Interior at second level

1. Current restroom renovations prohibit preservation of structure to original house plan. Future use will determine needs of this area.
2. Water damage evident at concession stand ceiling, typ. Remove and replace ceiling deck; further damage assesment will be necessary.
3. Light fixtures require bulb guards; electrical work not installed to workman-like standard. Remove and replace with fixtures suited to future use.
4. Vine growth spread to interior, damaging walls. Remove source of vine growth and repair walls as necessary.
5. Plumbing and electrical services exposed; some appear abandoned. Unable to determine if functional; determine future needs and repair or replace as necessary.
6. Water damage at quarry tile floor. Remove and replace with sympathetic flooring.

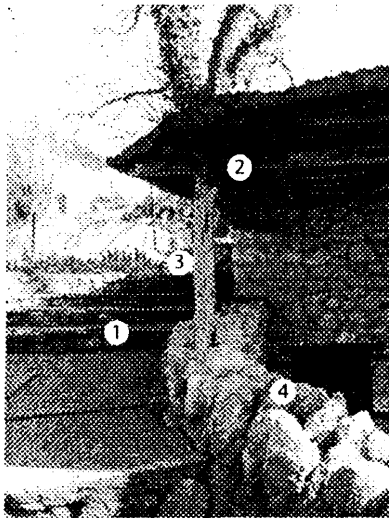
B1- Stairs at Northwest corner

1. Edge of steps from Jingu House in disrepair, present unsafe condition
2. Porch roof plane overhangs stairs; does not meet ADA clearance requirements.
3. No handrail at stairs; Install/repair period sensitive railing where needed.
4. Retaining wall showing cracks, instability. Repair and repoint mortar as necessary.
5. Entry from main path is inaccessible. Incorporate overall accessible path to Historic Mexican Village.
6. Wood railing showing water rot; replace damaged railing and repair.
7. Concrete porch floor sheared, presents unsafe condition. Relevel floor for safety and watershed.
8. Vertical crack at retaining wall; repair and repoint mortar as necessary.
9. Exposed conduit, light fixture; remove and replace with sympathetic fixture or install concealed security lighting only.
10. Insect damage at porch roof; repair or replace damaged boards.

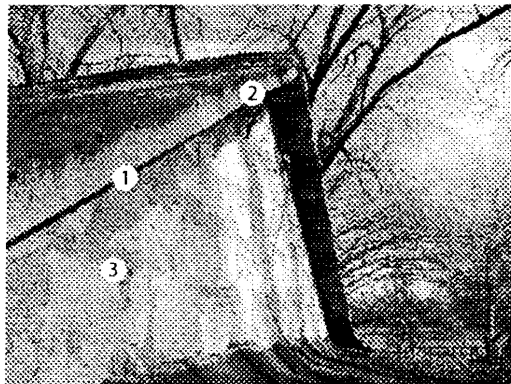
B5- Roof at West facade

1. Corrugated roof deteriorated, typ. Remove, repair structure, and replace with period sensitive roof.
2. Exposed wiring; remove all nonfunctional wiring and devices.

3. Area of apparent mortar repair/patching. Remove and replace with period sensitive mortar repair.
4. Wood trellis structure deteriorated & showing water damage, typ. Remove and repair structure, and decking.

5. Nails exposed where rot has occurred; repair or replace structure.
6. Corrugated roof buckling; remove, repair structure, and replace with period sensitive roof.

7. Wood decking deteriorated & showing water damage, typ. Repair or replace damaged boards.
8. Trellis structure overrun with dead plant growth, typ. Remove source of growth and repair or replace damaged structure.

9. Insect damage at porch roof; repair or replace damaged boards.
10. Wood railing in disrepair, missing some locations. Install/repair period sensitive railing where needed.

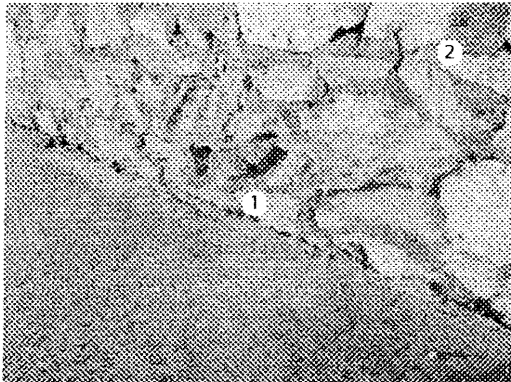
B9- Porch roof at Sout facade

1. Stone masonry spalling off at building base; remove and replace deteriorating stone.
2. Area of apparant mortar repair/patching; remove and replace with period sensitive mortar repair.
3. Continuous vertical crack around opening; assess structural stability and repair/repoint mortar as necessary.
4. Exposed wood deteriorating; replace where necessary; determine suitability for future use.
5. Major water damage at door threshold; remove deteriorated wood and replace with period door.
6. Water damage to chimney where exposed. Chimney cap deteriorated; repair and clean stone; repair and repoint mortar where necessary. Determine suitability for fireplace use for future needs.
7. Corrugated roof deteriorated, buckling. Remove, repair structure, and replace with period sensitive roof.

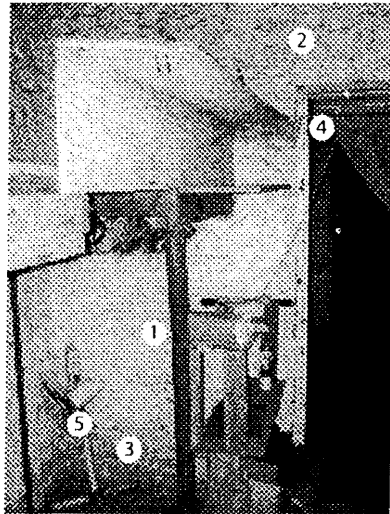
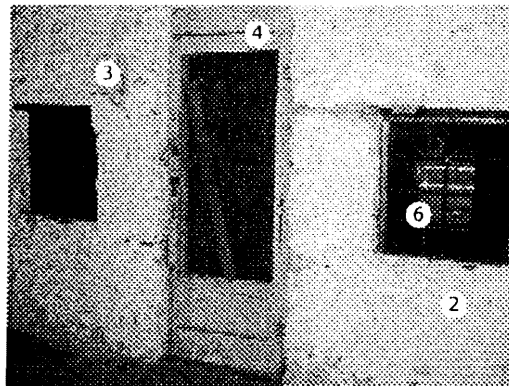
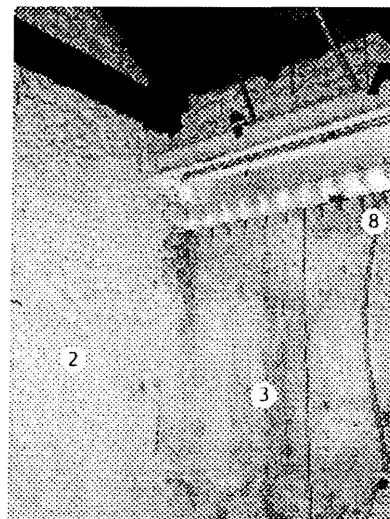
1. Remove all built-ins
2. Stone masonry painted, typ.
3. Water damage to walls; deteriorating stone, typ. Determine future use and repair damage as necessary.
4. Wood door frames deteriorated; remove and replace with period door
5. Remove abandoned personal effects
6. Window infill unsympathetic; remove and replace with period sensitive window treatment.
7. Exposed fiberglass batt insulation; remove and install insulation as appropriate for future use.
8. Exposed electrical conduit, fixtures; remove and replace with period sensitive fixtures and concealed conduit.

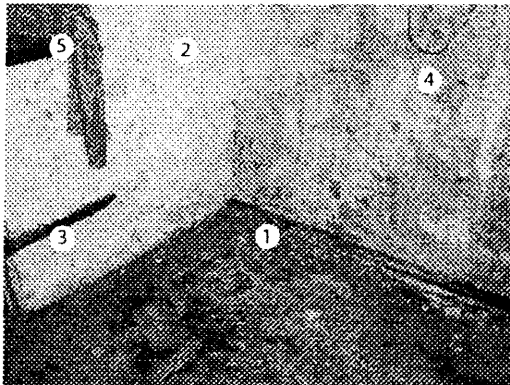
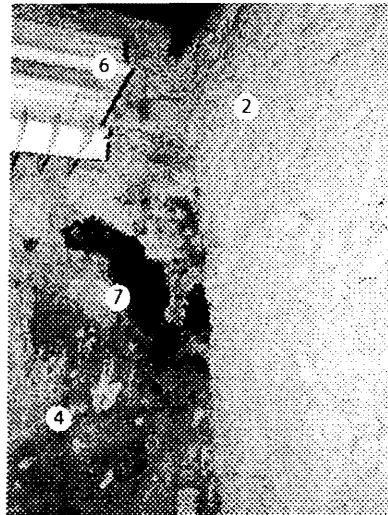
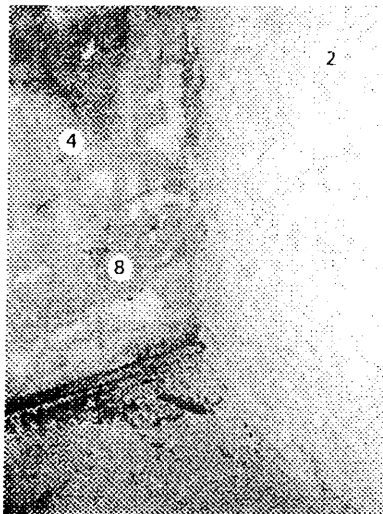
1. Concrete floor in disrepair, typ. Repair, re-level, and clean as necessary for future use.
2. Stone masonry painted, typ.
3. Exposed wood deteriorating; remove and replace as necessary.
4. Water damage to walls, deteriorating stone, typ. Determine future use and repair damage as necessary.
5. Remove abandoned personal effects
6. Exposed electrical fixture; remove and replace with period sensitive fixtures and concealed conduit.
7. Mold growth on walls; Determine future use and repair damage as necessary.
8. Vertical crack from base of wall to corner; repair and repoint mortar as necessary.

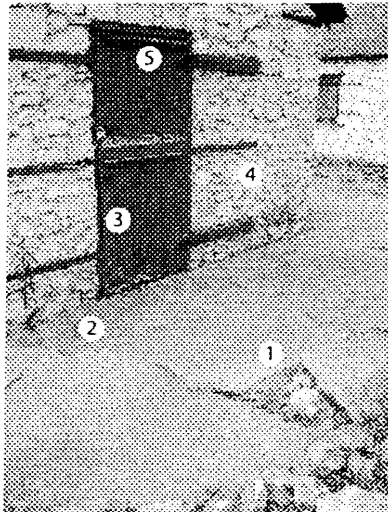
C1- Front entry at South facade

1. Concrete slab sheared, broken; path is inaccessible. Relevel floor and incorporate overall accessible path to Mexican Village.
2. Grade slopes in towards building, apparant water damage. Regrade or repave concrete slab for watershed; clean and repair damaged stone.
3. Exposed wood deteriorating, typ. Replace where necessary.
4. Area of apparant mortar repair/ patching; remove and replace with period sensitive mortar repair.
5. Door does not meet ADA clearance requirements.
6. Exposed /overhead electrical and telephone service; remove all nonfunctional wiring and devices.
7. Remove and replace deteriorated wood blocking.
8. Unsympathetic repair at window shutters; replace.
9. Curb presents unsafe or inaccessible condition.
10. Remove light fixture; replace with sympathetic fixture or install concealed security lighting only.
11. Brick pavers in disrepair; remove and repave area.

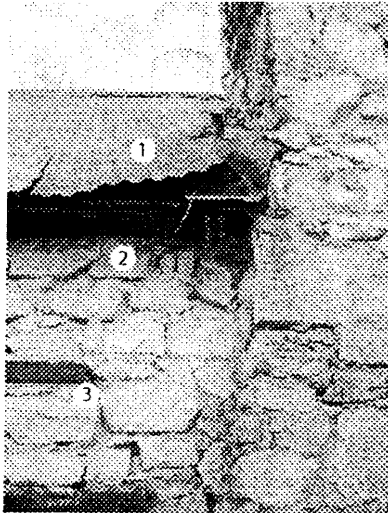
C5- West facade at chimney

1. Corrugated roof deteriorated, buckling, typ. Remove, repair structure, and replace with period sensitive roof.
2. Area of apparant mortar repair/patching; remove, repair structure, and replace with period sensitive roof.
3. Vertical crack; repair and repoint mortar as necessary.
4. Wood decking & roof structure deteriorated. Repair or replace structure.
5. Insulation penetrating building envelope; remove and seal building envelope.
6. Remove light fixture; replace with sympathetc fixture or install concealed security lighting only.
7. Grade slopes in towards building; apparant water damage. Regrade or repave concrete slab for watershed; clean and repair damaged stone.
8. Original porch and roof structure has been removed; determine feasibility of restoration.
9. Original breezeway structure removed; determine feasibility of restoration.
10. Tree roots destabilizing concrete slab

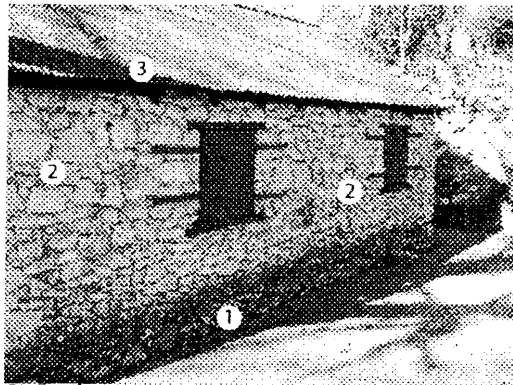
C8- East facade

1. Grade slopes in towards building; apparant water damage. Regrade or repave concrete slab for watershed; clean and repair damaged stone.
2. Area of apparant mortar repair/patching; remove and replace with period sensitive mortar repair.
3. Corrugated roof deteriorating; remove, repair structure, and replace with period sensitive roof.
4. Nails exposed where rot has occured; repair or replace structure.
5. Exposed wood deteriorated; repair or replace as necessary.
6. Door does not meet ADA clearance requirements
7. Water damage to stone masonry at chimney; repair at damaged areas.
8. Chimney cap deteriorated; repair and clean stone, repair and repoint mortar where necessary. Determine suitability for fireplace use for future needs.
