AN ORDINANCE      2008 - 01 - 31 - 0085

**APPROVING A MASTER PLAN FOR THE JAPANESE TEA GARDEN IN BRACKENRIDGE PARK DEVELOPED IN COOPERATION WITH THE SAN ANTONIO PARKS FOUNDATION, AND THE FRIENDS OF THE PARKS.**

existing conditions :: limit of work

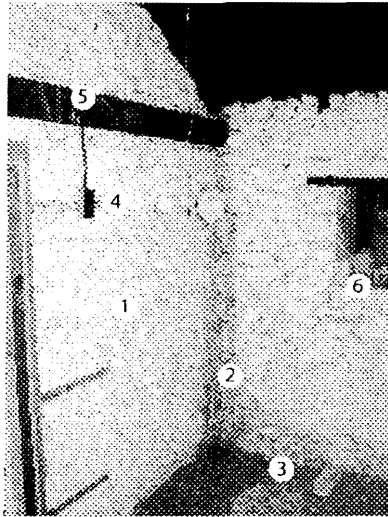
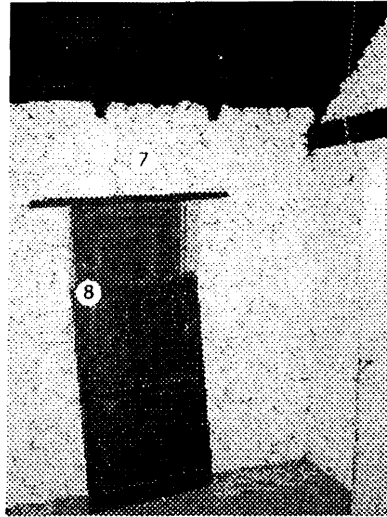
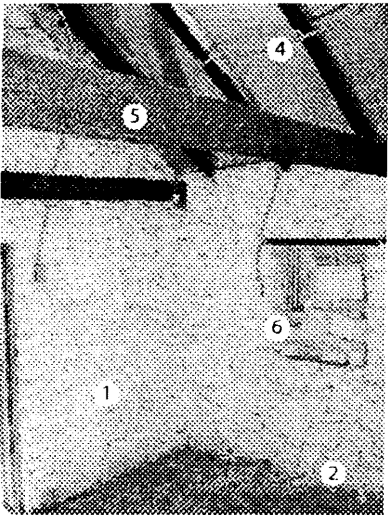
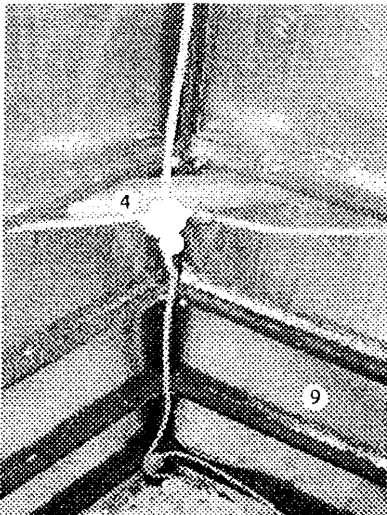
1. Stone masonry painted, typ.
2. Water damage to walls, deteriorating stone, typ. Determine future use and repair damage as necessary.
3. Concrete floor in disrepair. Repair, re-level, and clean as necessary for future use.
4. Exposed electrical switch/fixture, conduit; remove and replace with period sensitive fixtures and concealed conduit.
5. Wood structure requires restoration
6. Loose infill at window locations; remove and replace with period sensitive window treatment.
7. Continuous vertical crack above window; repair and repoint mortar as necessary for stability.
8. Windows/shutters in disrepair; remove and replace with period sensitive window treatment.
9. Remove insulation at ceiling; check for additional water damage at decking and repair as necessary.

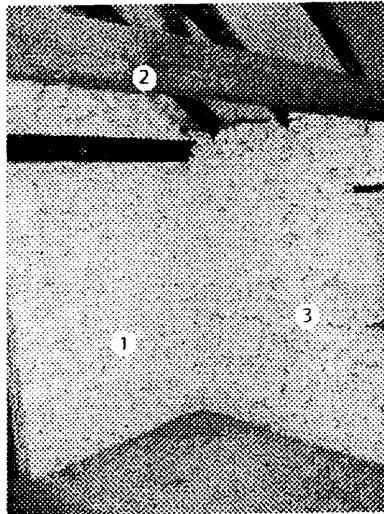
1. Stone masonry painted, typ.
2. Wood structure requires restoration
3. Stone masonry requires repair/repointing, typ.
4. Exposed electrical switch/fixture, conduit. Remove and replace with period sensitive fixtures and concealed conduit.
5. Remove insulation at ceiling; check for additional water damage at decking and repair as necessary.
6. Water damage to walls, deteriorating stone, typ. Determine future use and repair damage as necessary.
7. Fireplace in disrepair; restore and repair as needed.
8. Concrete floor in disrepair. Repair, re-level, and clean as necessary for future use.
9. Wood door in poor condition; repair as needed.

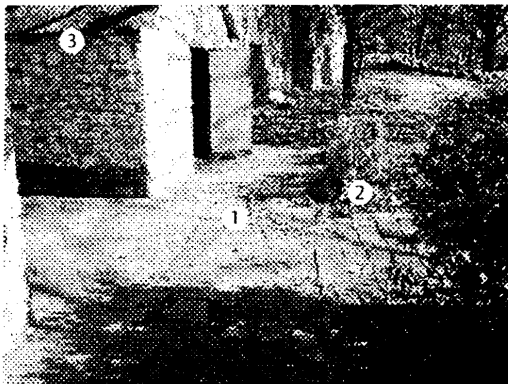
D1- Front entry at Southwest corner

1. Concrete slab cracked/broken, presents unsafe condition; relevel and repair slab for safety and watershed.
2. Plant growth expanding into path; remove source of growth and restore path as needed.
3. Breezeway no longer present; determine feasibility of restoration.
4. Door does not meet ADA clearance requirements
5. Path is inaccessible; incorporate overall accessible path at Historic Mexican Village.
6. Overhead electrical / telephone service; remove all nonfunctional wiring and devices.
7. Area of apparant mortar repair/ patching; remove and replace with period sensitive mortar repair.
8. Grade above building base; regrade for adequate watershed.
9. Exposed wood deteriorated, typ. Determine needs for future use and replace as necessary.
10. Water damage at stone masonry chimney; repair and clean stone; repair and repoint mortar where necessary.

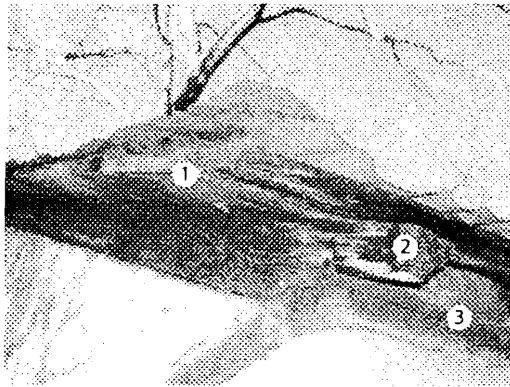
D5- Roof at Southeast corner

1. Corrugated roof deteriorated, buckling typ. Remove, repair structure, and replace with period sensitive roof.
2. Exposed wood deteriorating, typ. Remove and replace as necessary.
3. Insulation penetrating building envelope; remove and seal building envelope.
4. Area of apparant mortar repair/ patching; remove and replace with period sensitive mortar repair.
5. Door does not meet ADA clearance requirements
6. Original porch and roof structure has been removed; determine feasibility of restoration.
7. Chimney cap missing

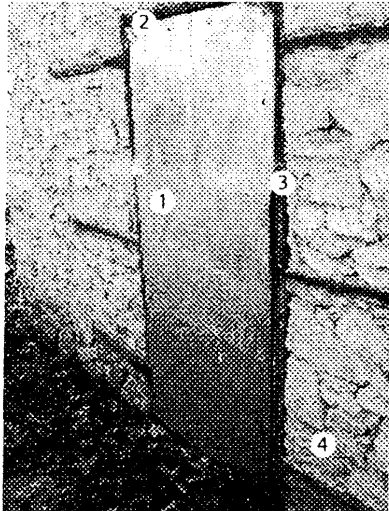
D8- Rear entry at North facade

1. Unsympathetic repair to door; remove and replace with period door.
2. Door does not meet ADA clearance requirements
3. Exposed wood deteriorating; remove and replace as necessary.
4. Stone masonry spalling at building base; remove and replace deteriorating stone.
5. Concrete infill at windows; remove and replace with period sensitive window treatment.
6. Area of apparant masonry repair/patching; remove and replace with period sensitive mortar repair.
7. Corrugated roof deteriorated, buckling. Remove, repair structure, and replace with period sensitive roof.
8. Wood doors deteriorated due to water/insect damage. Remove and replace with period sensitive doors.
9. Continuous crack next to door; assess structural stability and repair/ repoint mortar as necessary.

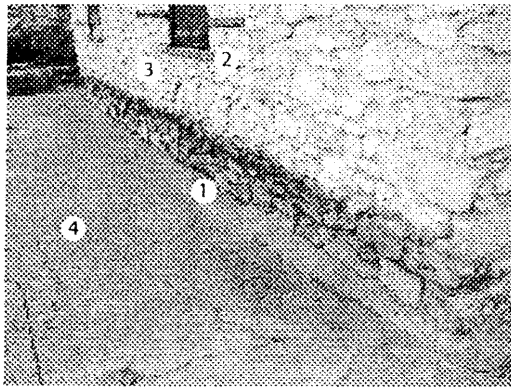
D12- West facade

1. Grade slopes toward building; apparant water damage at splash zone; regrade at buildinbg base for adequate watershed.
2. Exposed wood deteriorated; remove and replace as necessary
3. Cracks around openings; repair and repoint mortar as necessary
4. Breezeway no longer present; determine feasibility of restoration.
5. Water damage to stone masonry at chimney; repair and clean stone; repair and repoint mortar where necessary.
6. Vertical crack; assess structural stability and repair/repoint mortar as necessary.
7. Corrugated roof deteriorated. Remove, repair structure, and replace with period sensitive roof.
8. Grade above building base. Regrade for adequate watershed.

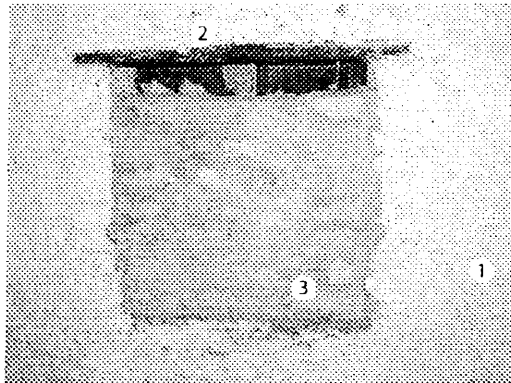
D14- Interior

1. Stone masonry painted, typ.
2. Exposed wood deteriorated, typ. Remove and replace as necessary.
3. Stone / brick infill at window. Remove and replace with period sensitive window treatment.
4. Water damage to stone masonry at wall base, typ. Determine future use and repair damage as necessary.
5. Fireplace in disrepair; restore and repair as needed.
6. Wood structure requires restoration
7. Concrete floor in disrepair; repair, re-level, and clean as necessary for future use.
8. Exposed bulbs; unsympathetic light fixtures. Remove and replace with period sensitive fixtures and concealed conduit.
9. Exposed conduit/ wiring. Remove all nonfunctional wiring and devices.
10. Deck deteriorated; remove and replace.

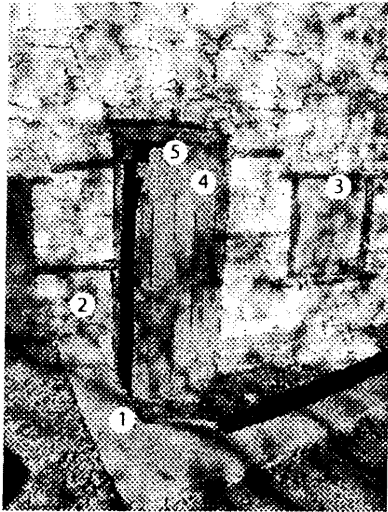
E1- Front entry at South facade

1. Inaccessible entry into building. Incorporate overall accessible path to Historic Mexican Village.
2. Vertical crack near window opening; repair and repoint mortar as necessary.
3. Unsympathetic repair at window; remove and replace with period sensitive window treatment.
4. Exposed wood door/window frame deteriorated; remove and replace.
5. Door does not meet ADA clearance requirements
6. Grade is above building base; regrade for adequate watershed.
7. Area of apparant mortar repair/ patching; remove and replace with period sensitive mortar repair.
8. Exposed roof structure deteriorated; remove and replace.
9. Exposed telephone service; remove all nonfunctional wiring and devices.
10. Transformer & pad should be relocated or concealed
11. Rear porch structure removed; determine feasibility of restoration.

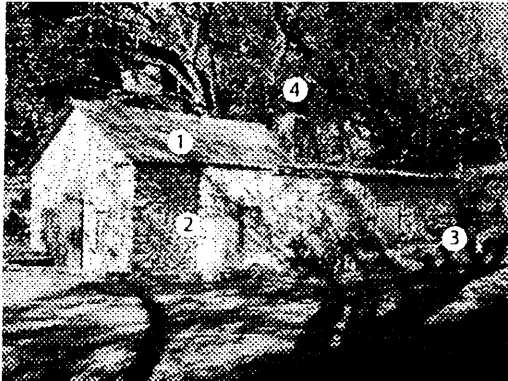
E5- Southeast corner from road

1. Corrugated roof and decking recently installed
2. Continuous vertical crack at inside corner at South side; assess structural stability and repair/repoint mortar as necessary.
3. Grade is above building base; regrade for adequate watershed.
4. Chimney top is deteriorated; determine suitability of fireplace use and restore or repair as needed.
5. New decking in good shape
6. Electrical conduit entry; remove all nonfunctional wiring and devices.
7. Exposed roof structure deteriorated. Remove and replace.
8. Exposed telephone service line; remove nonfunctional wiring and devices.
9. Area of apparent mortar repair/patching; remove and replace with period sensitive mortar repair.

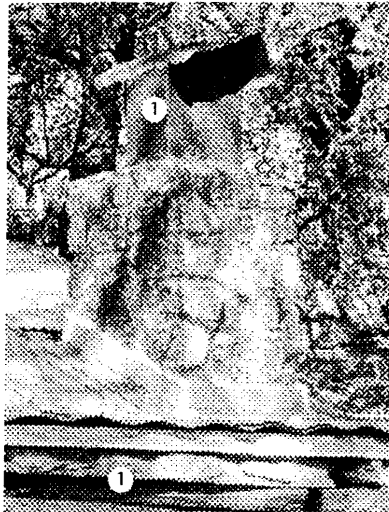
E8- Chimney at North facade

1. Chimney cap deteriorated; restore or repair as needed.
2. Exposed wood deteriorating. Remove and replace with period sensitive window treatment.
3. Continuous vertical crack from window opening to roofline; assess structural stability and repair/repoint mortar as necessary.
4. Area of apparant mortar repair/patching; remove and replace with period sensitive mortar repair.
5. Water damage at stone masonry; clean and repair as necessary.
6. Grade is above building base; regrade for adequate watershed.
7. Door does not meet ADA clearnace requirement
8. Stone masonry spalling near building base; remove and replace deteriorating stone.
9. Unsympathetic window repair; remove and replace with period sensitive window treatment.
10. Drainage at entryway recess

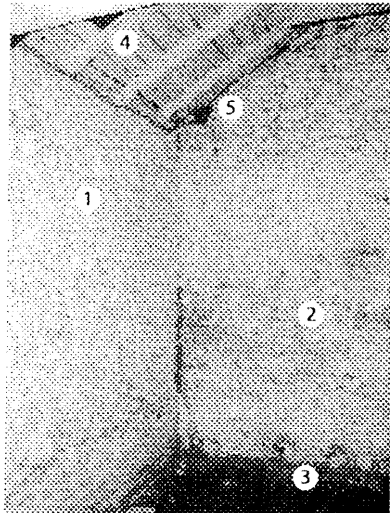
E11- Interior

1. Stone masonry painted, typ.
2. Water damage to stone masonry walls, typ. Determine future use and repair damage as necessary.
3. Concrete floor in disrepair; repair, re-level, and clean as necessary for future use.
4. New roof decking visible
5. Exposed electrical conduit; remove all nonfunctional wiring and devices.
6. Windows and doors in disrepair; remove and replace with period sensitive window treatment

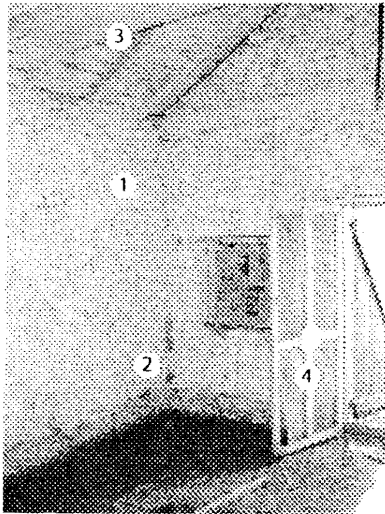
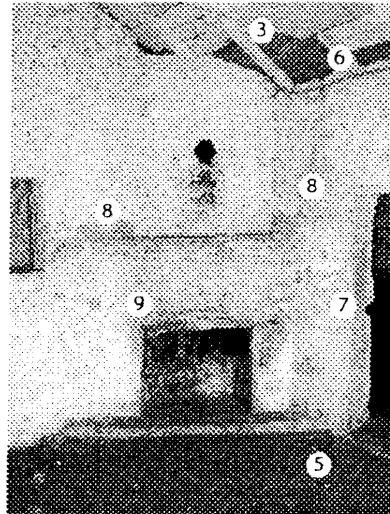
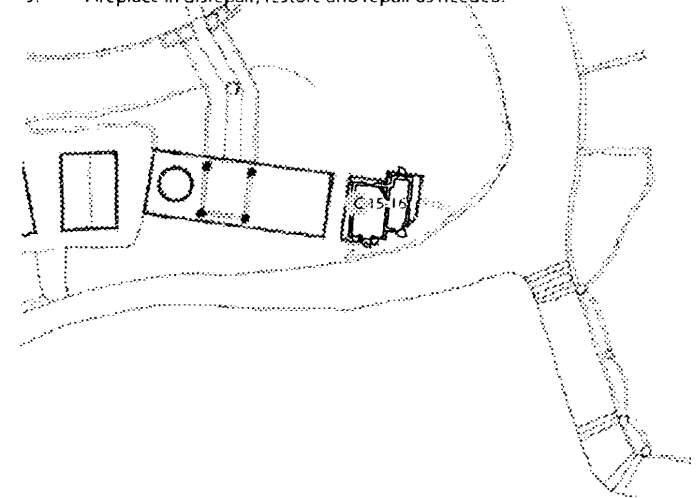
1. Stone masonry painted, typ.
2. Water damage to stone masonry walls, typ. Determine future use and repair damage as necessary.
3. Unsympathetic light fixture; remove and replace with period sensitive fixtures and concealed conduit.
4. Door in disrepair; repair as necessary.
5. Concrete floor in disrepair; repair, re-level, and clean as necessary for future use.
6. New roof decking visible
7. Door frame rotted; remove and replace.
8. Area of apparant mortar repair/ patching
9. Fireplace in disrepair; restore and repair as needed.

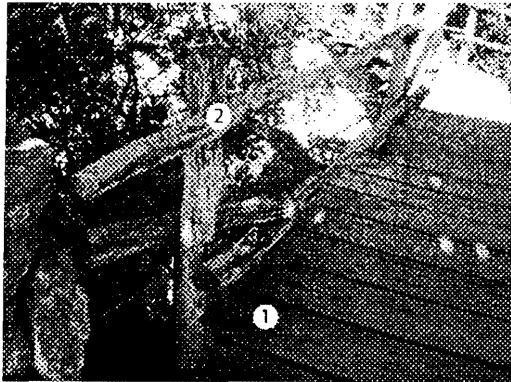
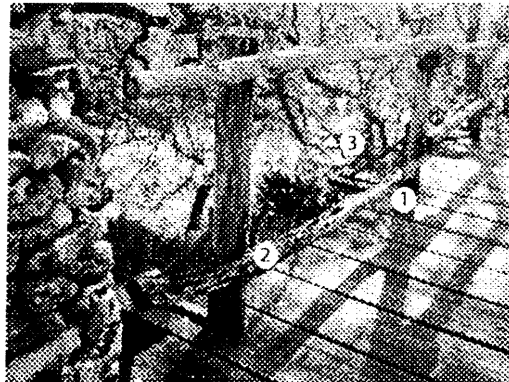
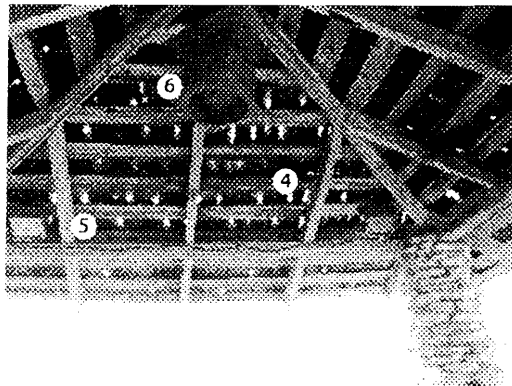
1. Wood bridge decking deteriorated; water damage apparant. Restore and repair as necessary to prevent further deterioration.
2. Hand rail deteriorated, nails exposed, guardrail not code compliant. Remove and install or repair period sensitive railing where needed.
3. Handrail bracing replaced with steel supports; remove and replace with period sensitive cedar post bracing as necessary.
4. Roof at overlook deteriorated, typ. Remove and replace with palapa-style roof.
5. Exposed wiring; remove all nonfunctional wiring and devices.
6. Unable to determine functionality of lighting; restore fixture and install electrical service as necessary.

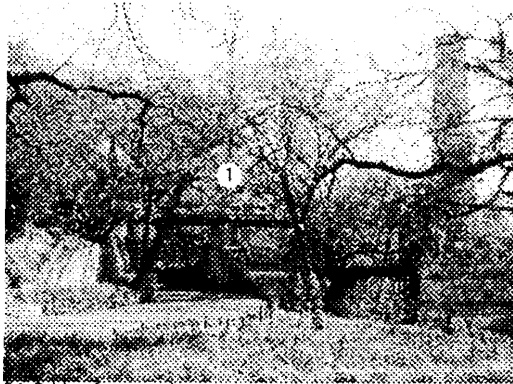
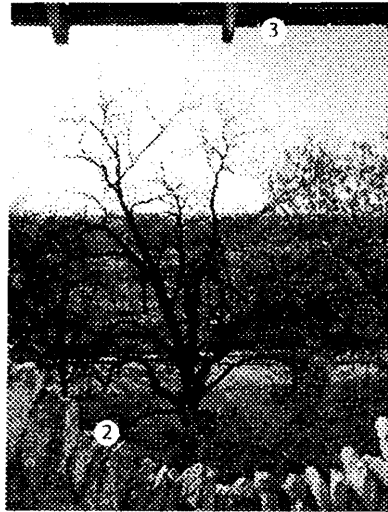
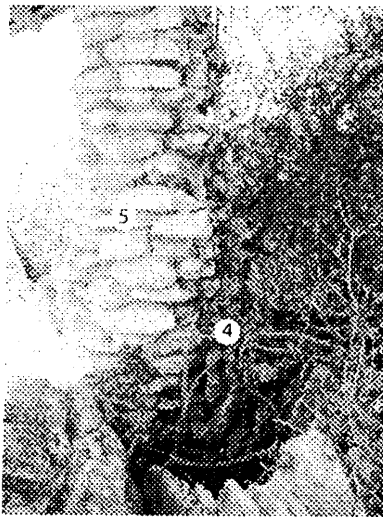
1. Thatched Palapa roof from pavillion no longer present
2. Insufficient guardrail at overlook, presents unsafe condition; determine need and install period sensitive railing where necessary.
3. Roof and structure deteriorated; remove and restore
4. Overgrowth of plants damaging stone masonry; remove source of growth and restore masonry where necessary.
5. Vertical crack at stone column; repair and repoint mortar as necessary.

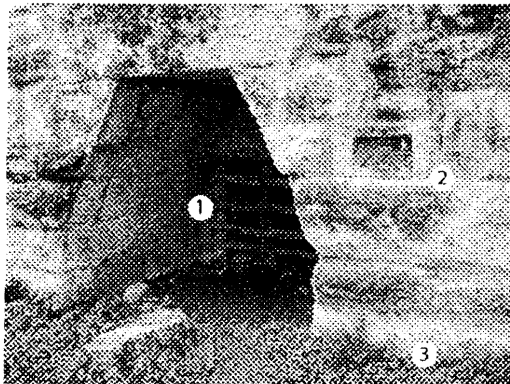
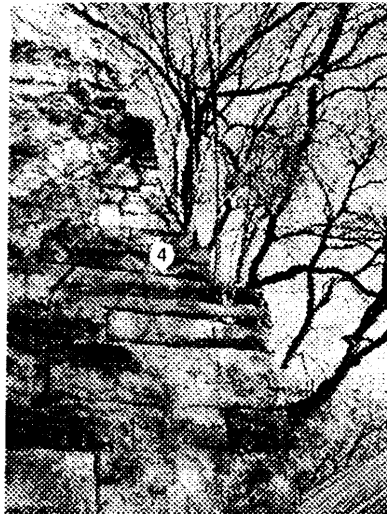
1. Kiln openings require cleaning, restoration
2. Plaque missing/removed from wall; stone masonry damaged; clean and restore.
3. Undefined landscape/ boundary at base. Determine needs for accessible path and delineate if needed.
4. Plant growth damaging historic features; remove source of growth or prohibit future growth and restore masonry where needed.
5. Existing electrical service; recommend removing or relocating
6. Smokestack vandalized near overlook; install preventative guardrail or other means of security.
